Fluvial Geomorphology and Culvert Assessment of the Meduxnekeag River Aroostook County, Maine

Houlton Band of Maliseet Indians
Littleton, Maine

Dr. John Field
Field Geology Services
Farmington, ME

July 2010

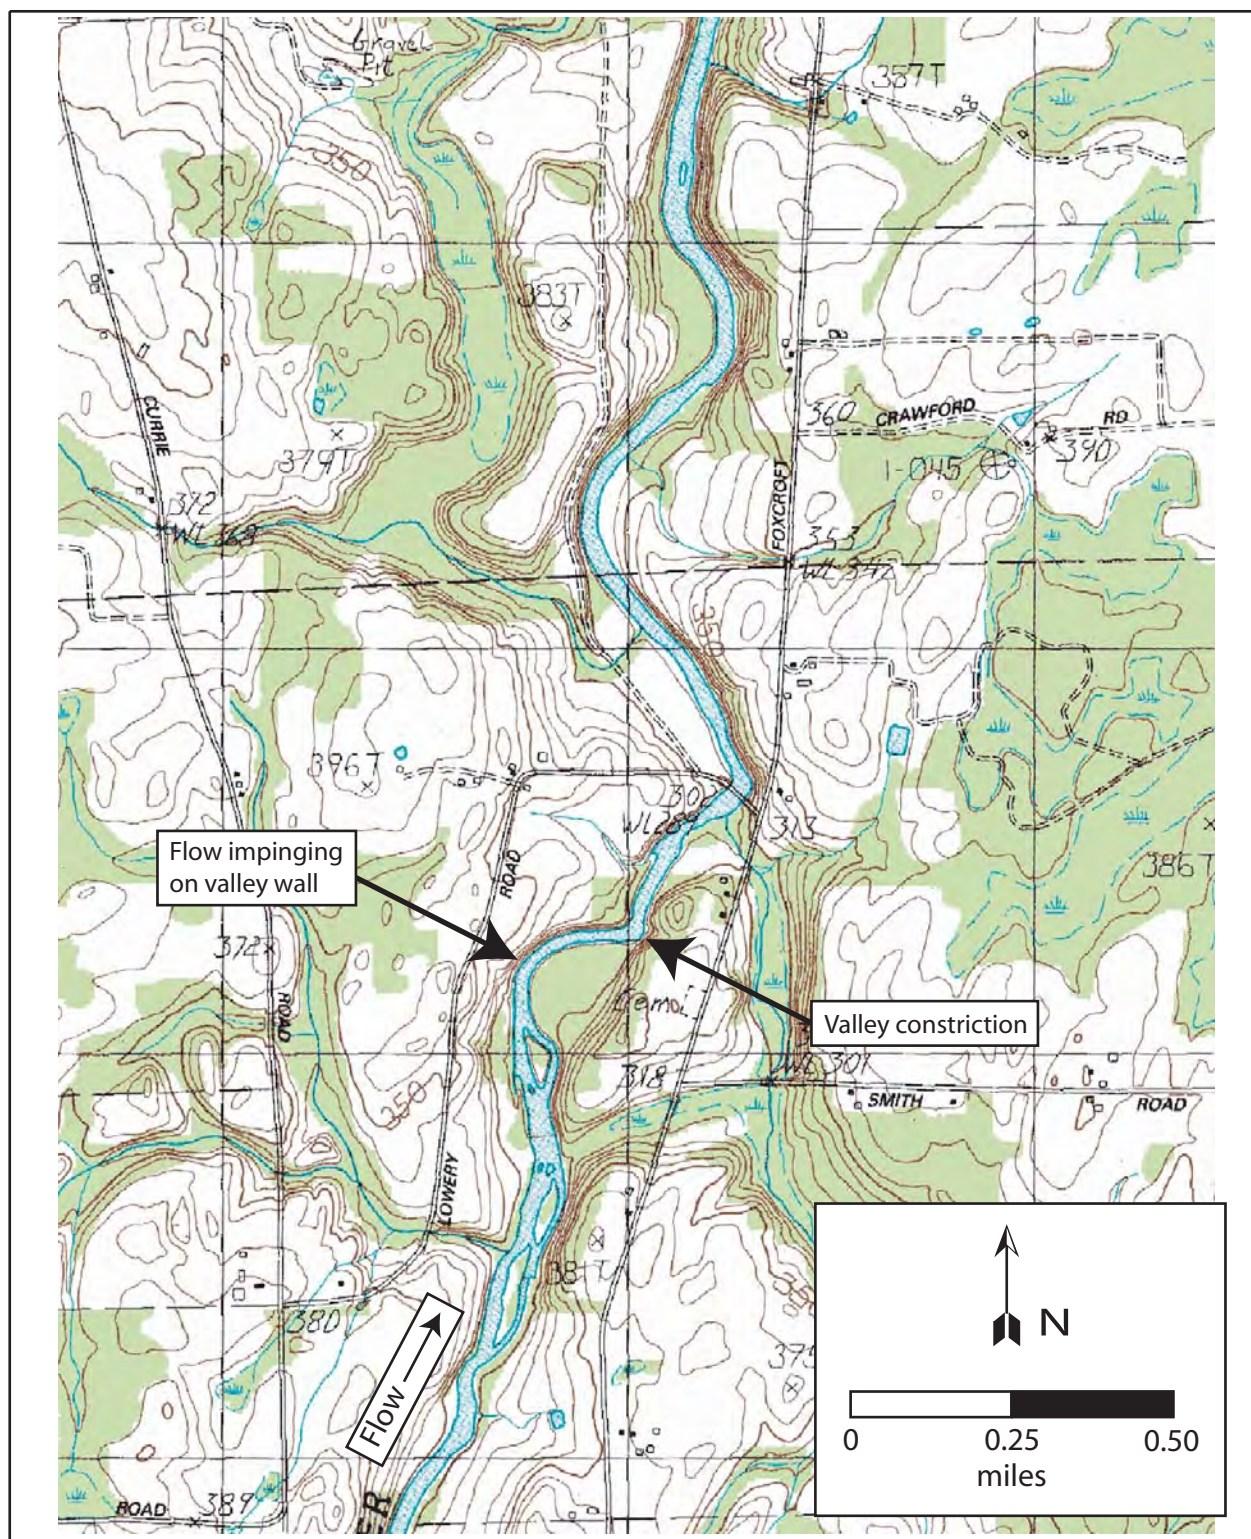
Figure 4. Topographic map of the Meduxnekeag River downstream of Houlton showing narrow valley through which the river flows. The river sometimes encounters the valley walls and valley constrictions.

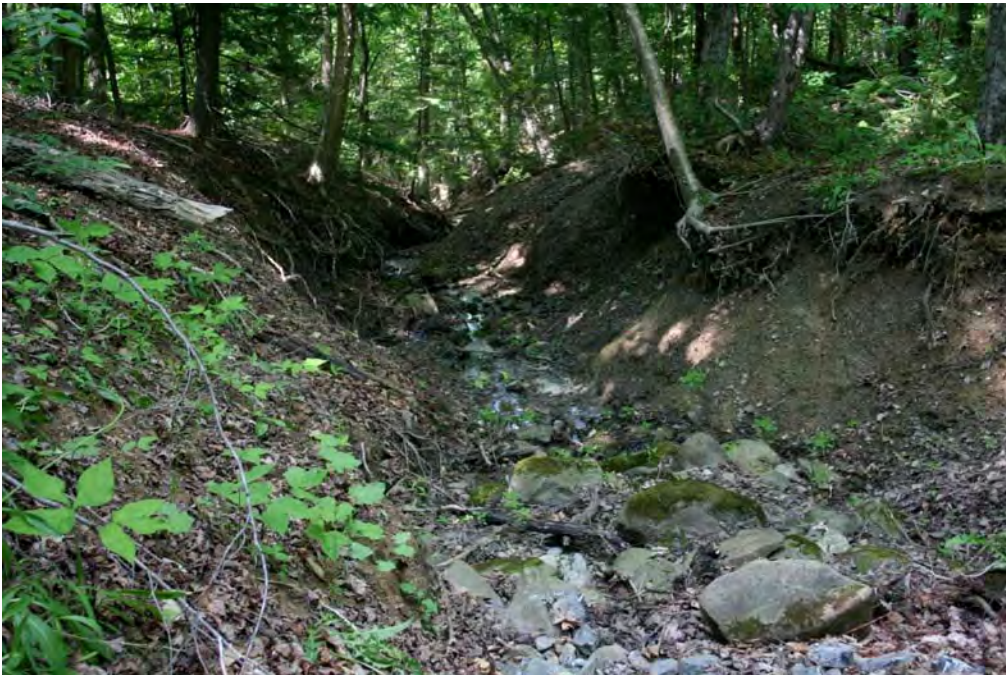
Figure 5. a) Sediment deposition directly into the Meduxnekeag River at the mouth of an unnamed tributary is b) enhanced by channel incision upstream caused by the concentration of flow after rebuilding of the Houlton Civic Center.

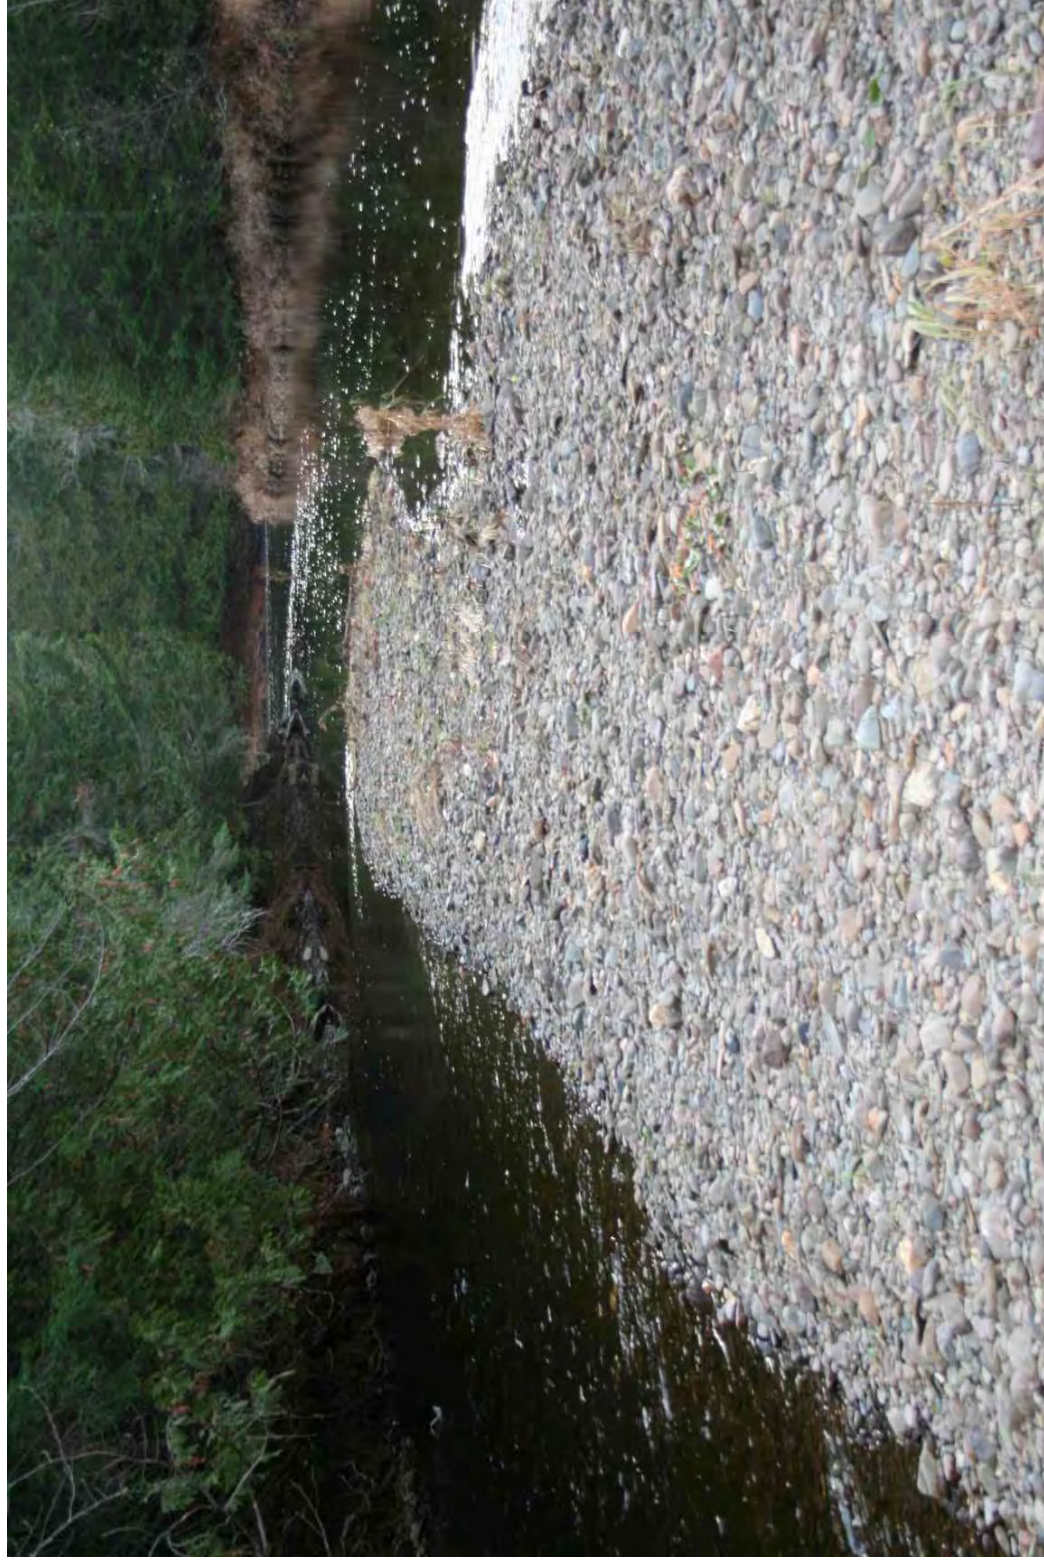
Figure 6. Gravel bar on B Stream deposited upstream of a valley constriction.

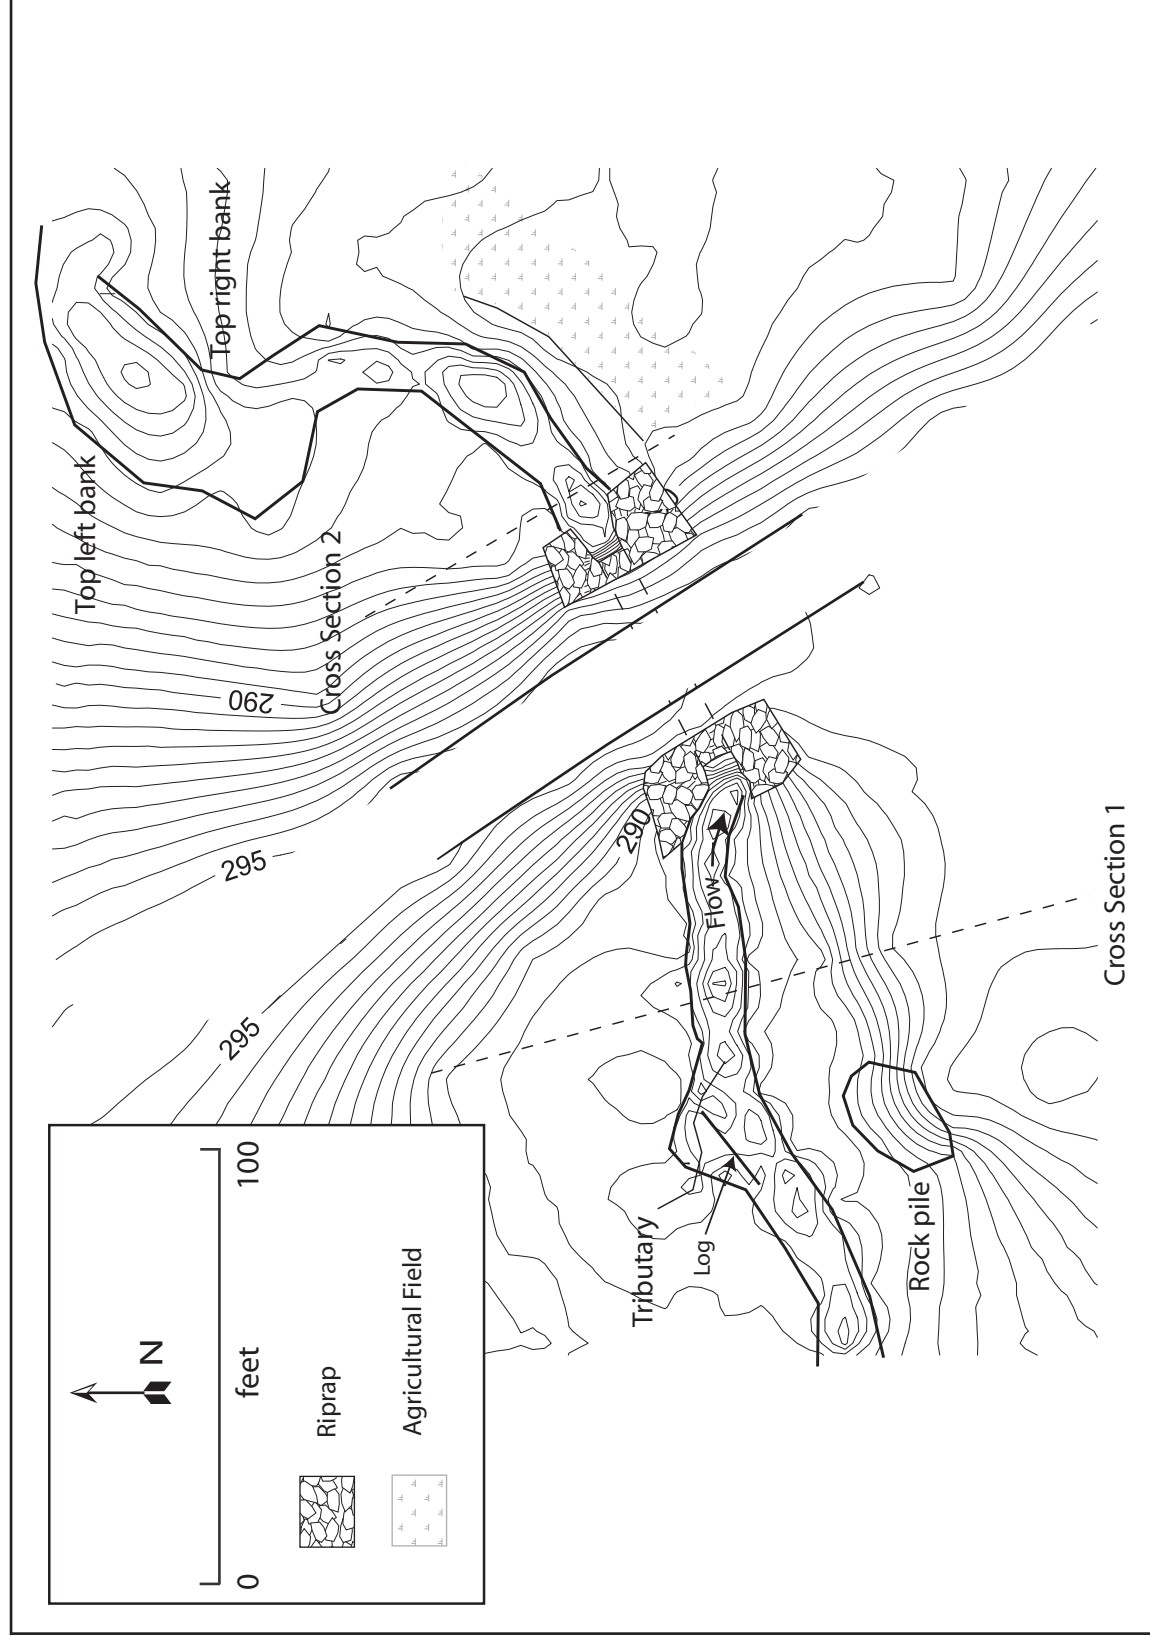
Appendix 6. Topographic survey data planview for Suiter Brook 1 Culvert Assessment Site.

The Suiter Brook 1 culvert significantly constricts the channel. On tribal lands, the culvert might be a good candidate as a demonstration project for culvert replacements with bottomless arch culverts spanning the channel width. However, the culvert was only recently replaced. Suiter Brook has a channel width of less than 20 ft, small enough that shrubby vegetation along the banks provides a canopy over the entire channel (Appendix 9). The dense vegetation and root mass in the bank may inhibit bank erosion and lead to the relatively low width:depth ratio (Table 4). The narrow channel precludes installing significant habitat measures but some small isolated logs placed at the downstream end of the culvert (Appendix 8) will baffle higher velocity flows exiting the highly constricted culvert, providing refuge for fish.
