# Pearce Brook Watershed Based Plan

Prepared by  
Southern Aroostook Soil and Water Conservation District  
Funded by the Environmental Protection Agency October,  
September 2012

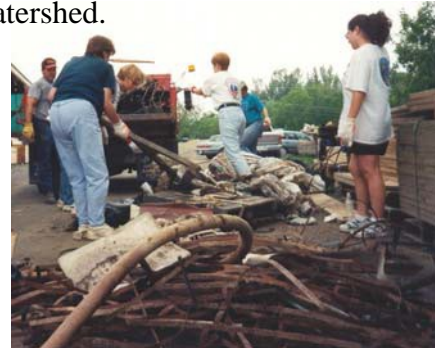
In 2007 HBMI and the Town of Houlton organized a successful Pearce Brook clean-up day where over 20 community volunteers picked up over a thousand pounds of trash in the stream and along its banks. Additionally, in the photo to the right, a clean-up day in the mid-1990's shows the pervasive problem of "garbage dumping" along the banks of Pearce that continues today, especially in the rural areas of the watershed.

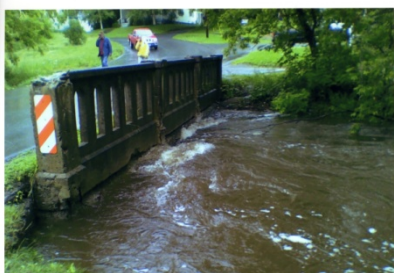
Green Street Bridge, June 2012

the work conducted upstream, downstream areas are now affected negatively as they are not appropriately sized to handle the new water volume levels. This includes the MDOT owned Green Street Bridge that is too small to accommodate the increased water volume during higher rainfall amounts and is prone to flooding, especially after ice build-up around the bridge that creates, in essence, a small dam. According to the afore mentioned 2010 fluvial geomorphology study, this stream crossing "is on the Maine Department of Transportation's priority

replacement list, so new culvert designs should plan for a channel spanning bottomless culvert to eliminate the severe constriction. Flood flows can overtop the low bridge and banks, so morphological effects are less severe."
