Fluvial Geomorphology and Culvert Assessment of the Meduxnekeag River Aroostook County, Maine

Houlton Band of Maliseet Indians
Littleton, Maine

Dr. John Field
Field Geology Services
Farmington, ME

July 2010

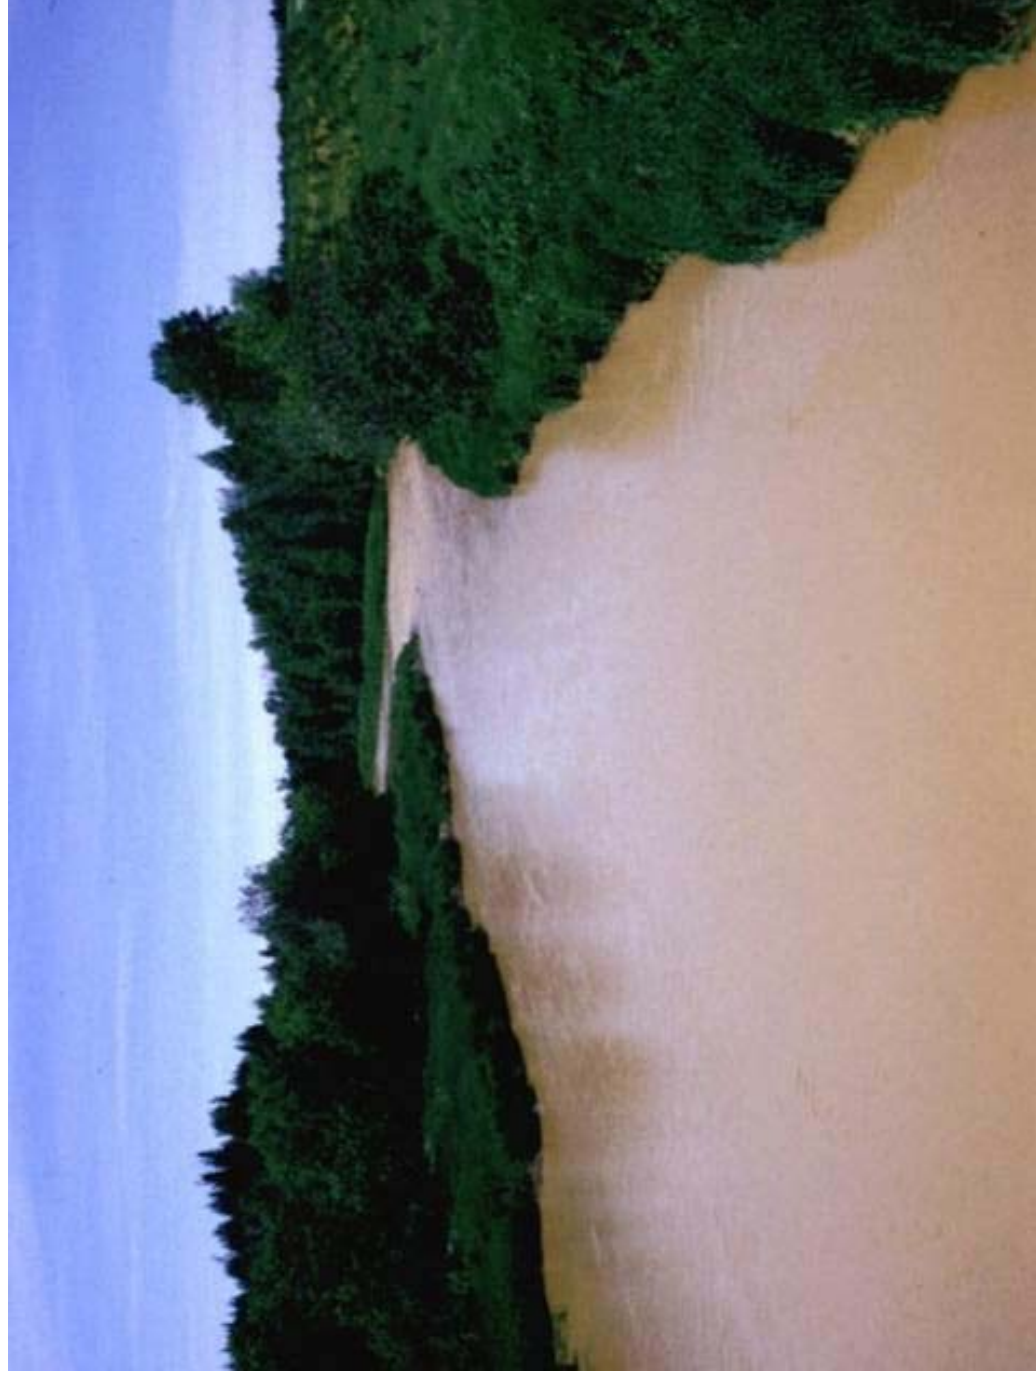
The assessments were completed for the Houlton Band of Maliseet Indians who have a long cultural tradition of utilizing the river's resources and have tribal lands in the watershed. Tribal culture is largely dependent upon the natural resources found in the waters, floodplains, and riparian zone of the Meduxnekeag River. The river is a critical link in preserving tribal practices, traditions, and history. The tribe's goal in conducting the assessments is to identify and implement restoration opportunities in the Meduxnekeag Watershed that will improve and promote traditional uses of the river such as fishing. A preliminary habitat assessment of the Meduxnekeag River completed by the Maine Inland Fisheries and Wildlife identified a preponderance of wide and shallow channels that lacked high quality pools and large woody debris, conditions associated with warmer summer water temperatures and less channel complexity (Frost, 2002). High sediment loads during runoff events (Schalk and Tornes, 2005) are also of concern, because of their potential to degrade habitat and adversely effect water quality. Even relatively small runoff events can rapidly turn the usually clear water very muddy (Figure 2).

Figure 2. The Meduxnekeag River flows very muddy during runoff events.

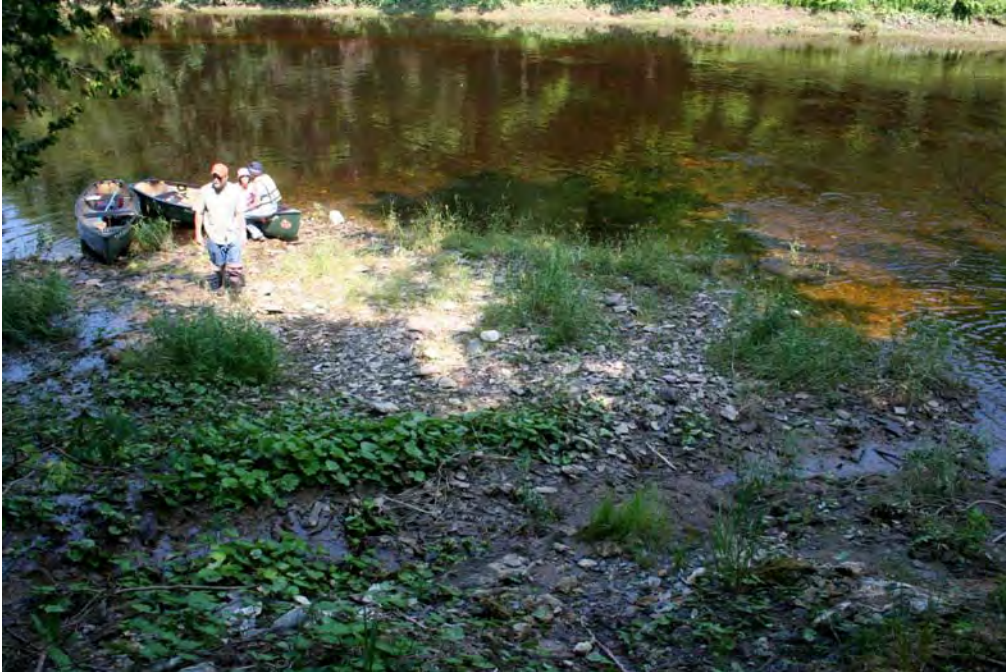
Once runoff from the Meduxnekeag Watershed reaches the river, the narrow valley through which much of the river flows has the potential to amplify river stage and promote rapid sediment deposition; both factors can potentially alter channel morphology and physical habitat dramatically. First, much of the river flows within a very narrow valley with no or very limited floodplain flanking the channel (Figure 4). Confined by the high valley walls, flood flows on the Meduxnekeag River move faster and flow at a greater depth for the same discharge compared to rivers with a wide floodplain. Given the narrow valley, the river impinges directly on the high banks of the valley wall at several locations (Figure 4), encountering both bedrock where deep pools can form and glacial deposits that can supply large amounts of fine sediment to the river in the event of a landslide. Another potential point source of sediments is from tributaries that flow directly into the river without a wide floodplain over which sediments can be stored, resulting in more direct impacts to channel morphology (Figure 5a). The problem can be made worse when land use activities in the tributary watershed are causing channel incision (Figure 5b).

Figure 5. a) Sediment deposition directly into the Meduxnekeag River at the mouth of an unnamed tributary is b) enhanced by channel incision upstream caused by the concentration of flow after rebuilding of the Houlton Civic Center.

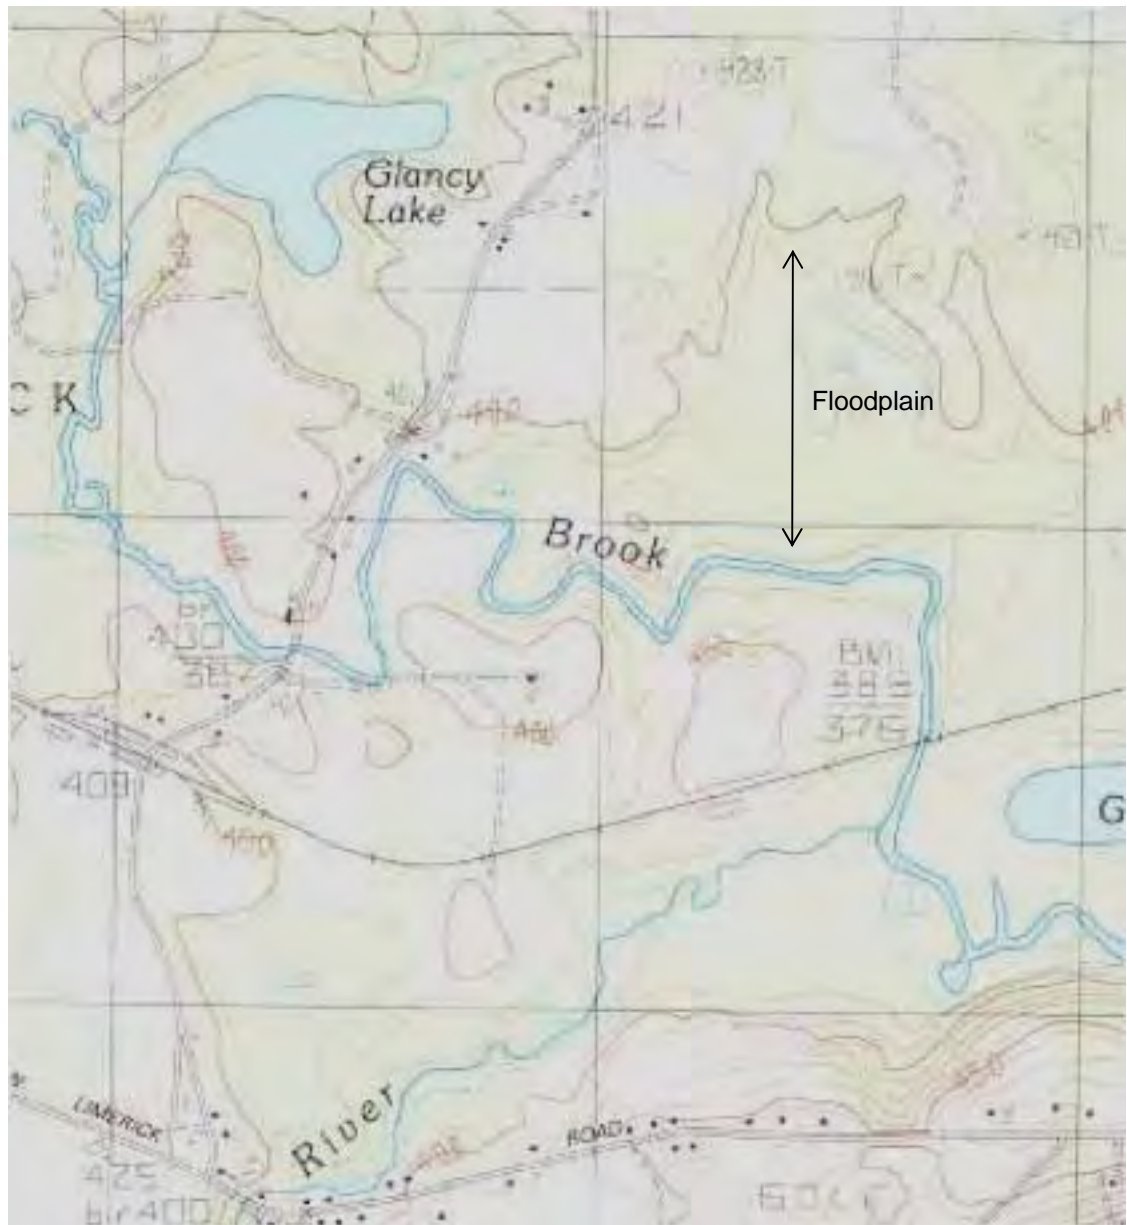
Figure 7. Artificial straightening probably occurred on lower Mill Brook where a straight channel is present along the valley margins despite an unconfined valley across which the channel could meander. Note presence of old meanders abandoned during the straightening.

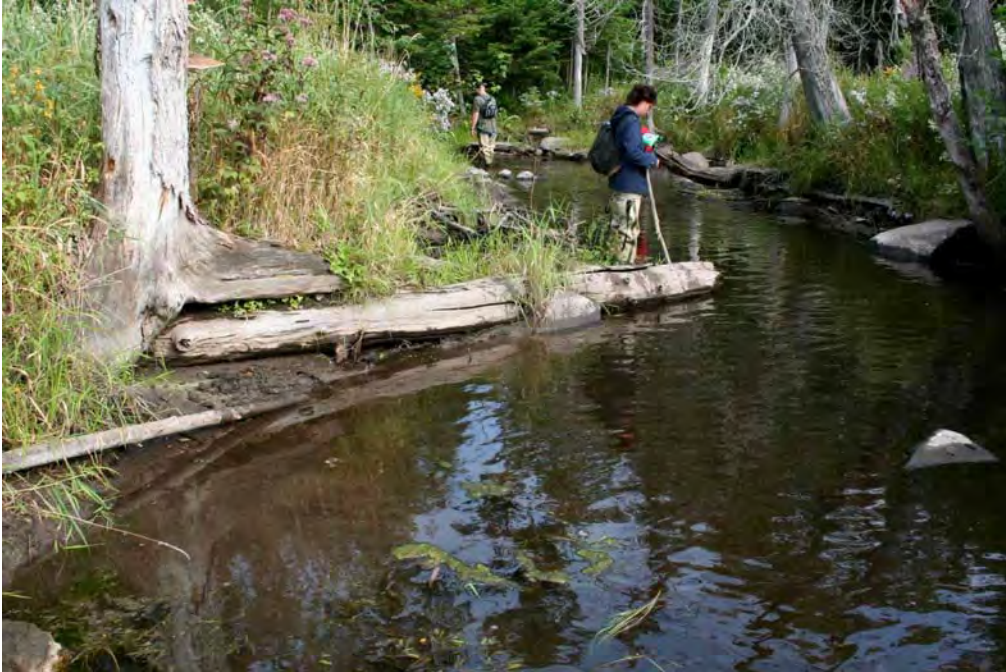
Figure 9. Evidence for old dams no longer existing can be seen as a) large logs protruding from the bank and oriented normal to flow and b) fine-grained impoundment sediments often containing abundant logs and wood fragments.

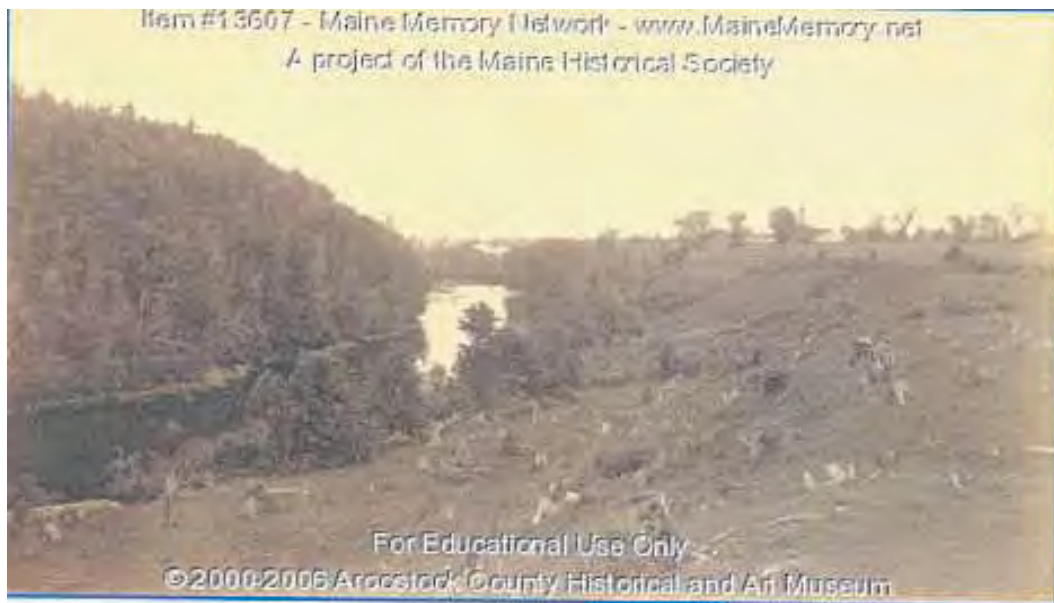
Figure 10. Photos highlighting change in land use 0.5 miles downstream of the old dam site in Houlton in a) upstream view circa 1890 showing agricultural land use on left bank (right of photo) and b) 2003 aerial photo showing deciduous tree growth in approximately the same location (outlined in blue box).

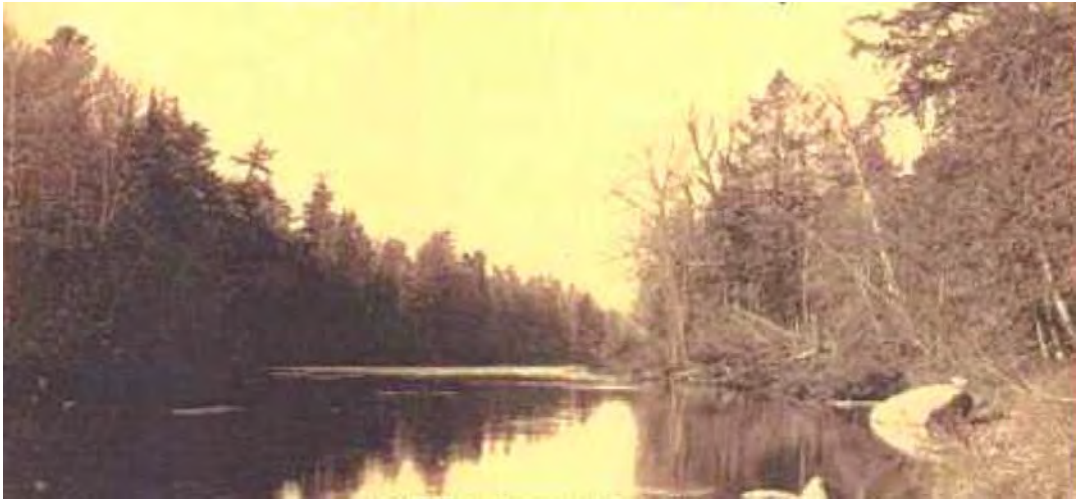
Figure 11. a) Historical photograph circa 1890 of the Meduxnekeag River downstream of Cooks Brook contrasts dramatically with b) a recent photograph of the same area showing I-95 bridge crossing that spans almost the entire channel.

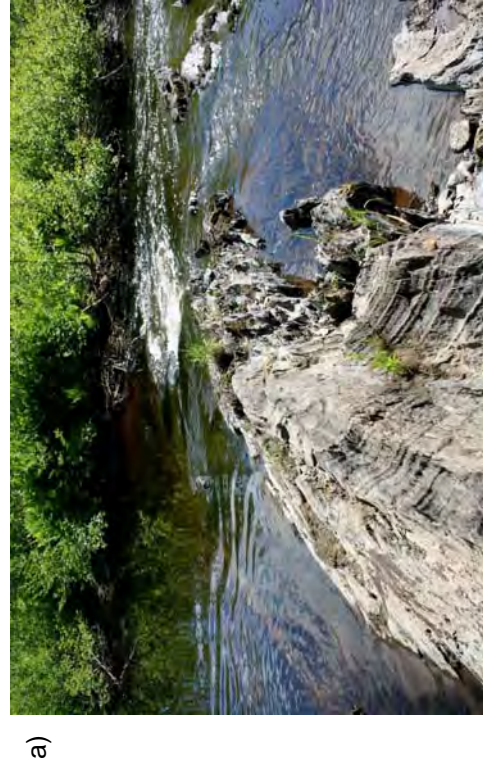
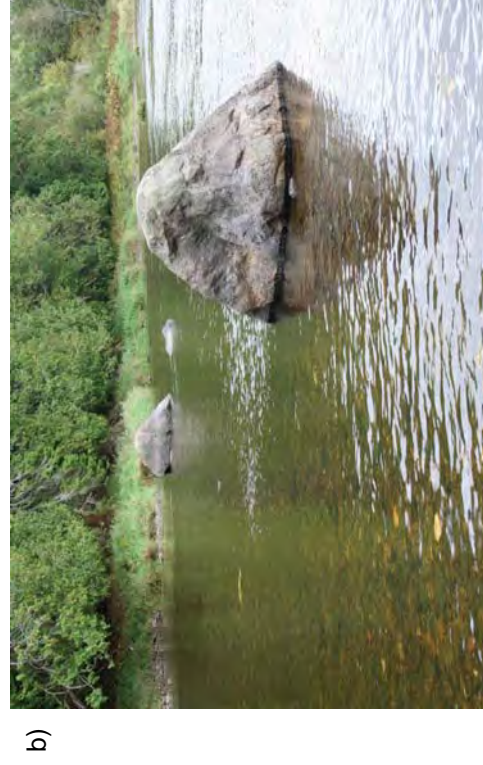
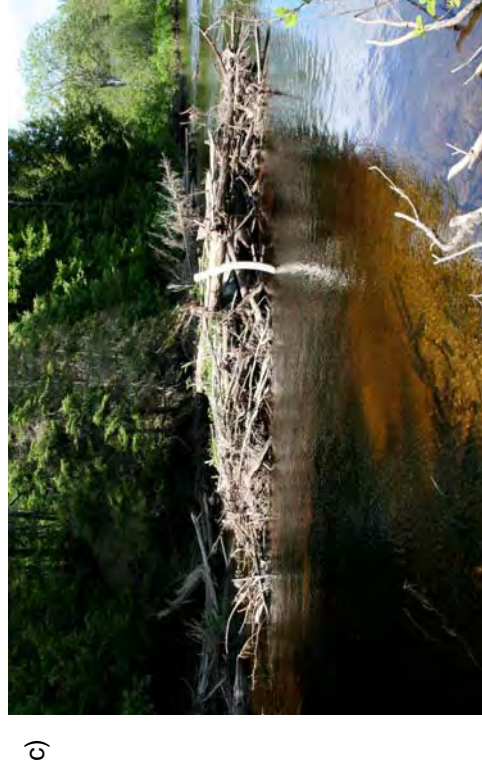
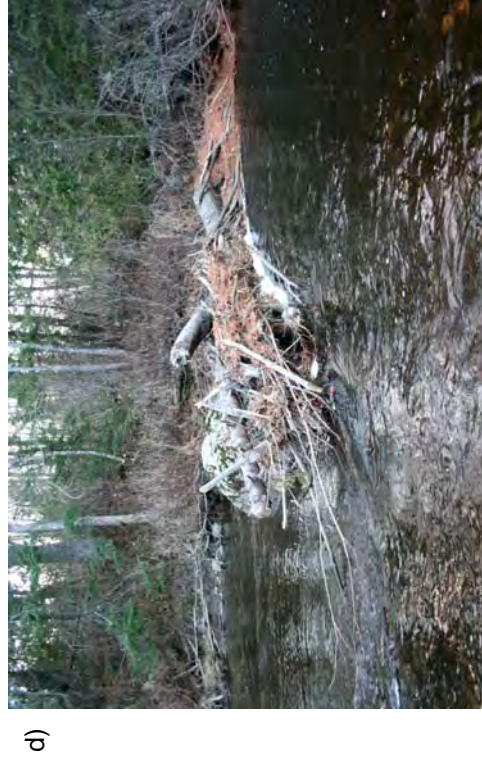
Figure 13. Flow complexity created by a) bedrock, b) isolated boulder, c) log jam, and d) boulder-supported log jam.

(Figure 13), engineered log jams are not incorporated into the conceptual restoration designs because of the greater costs and time associated with their construction; however, their use could be incorporated into future restoration efforts.

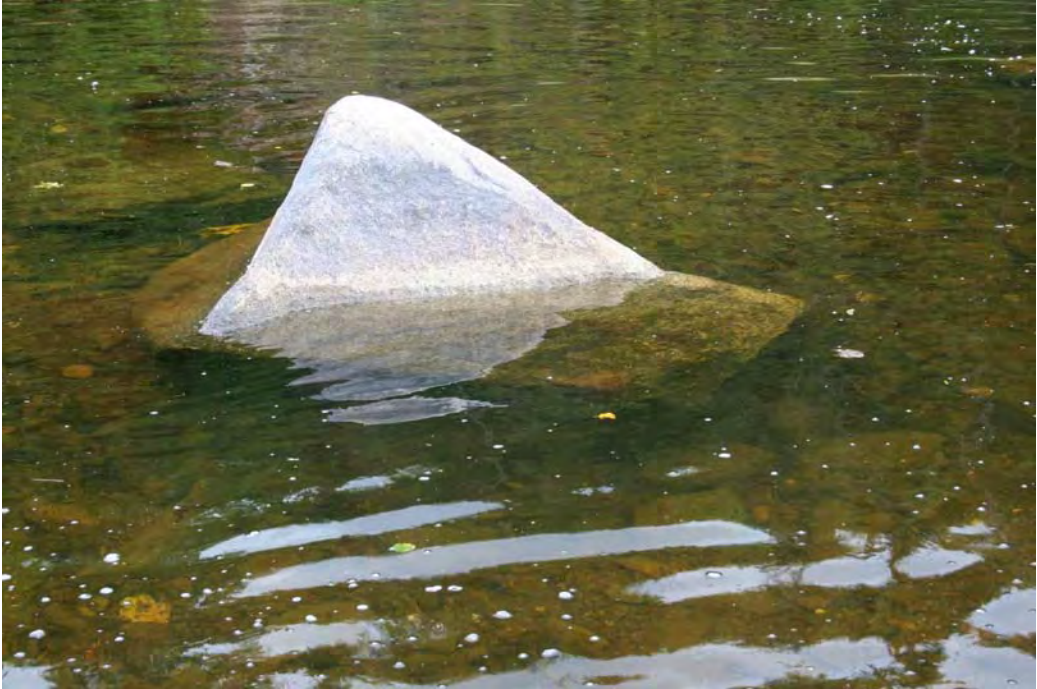
Figure 14. a) Deep pool formed around boulder and b) sand and gravel deposited upstream of log jam

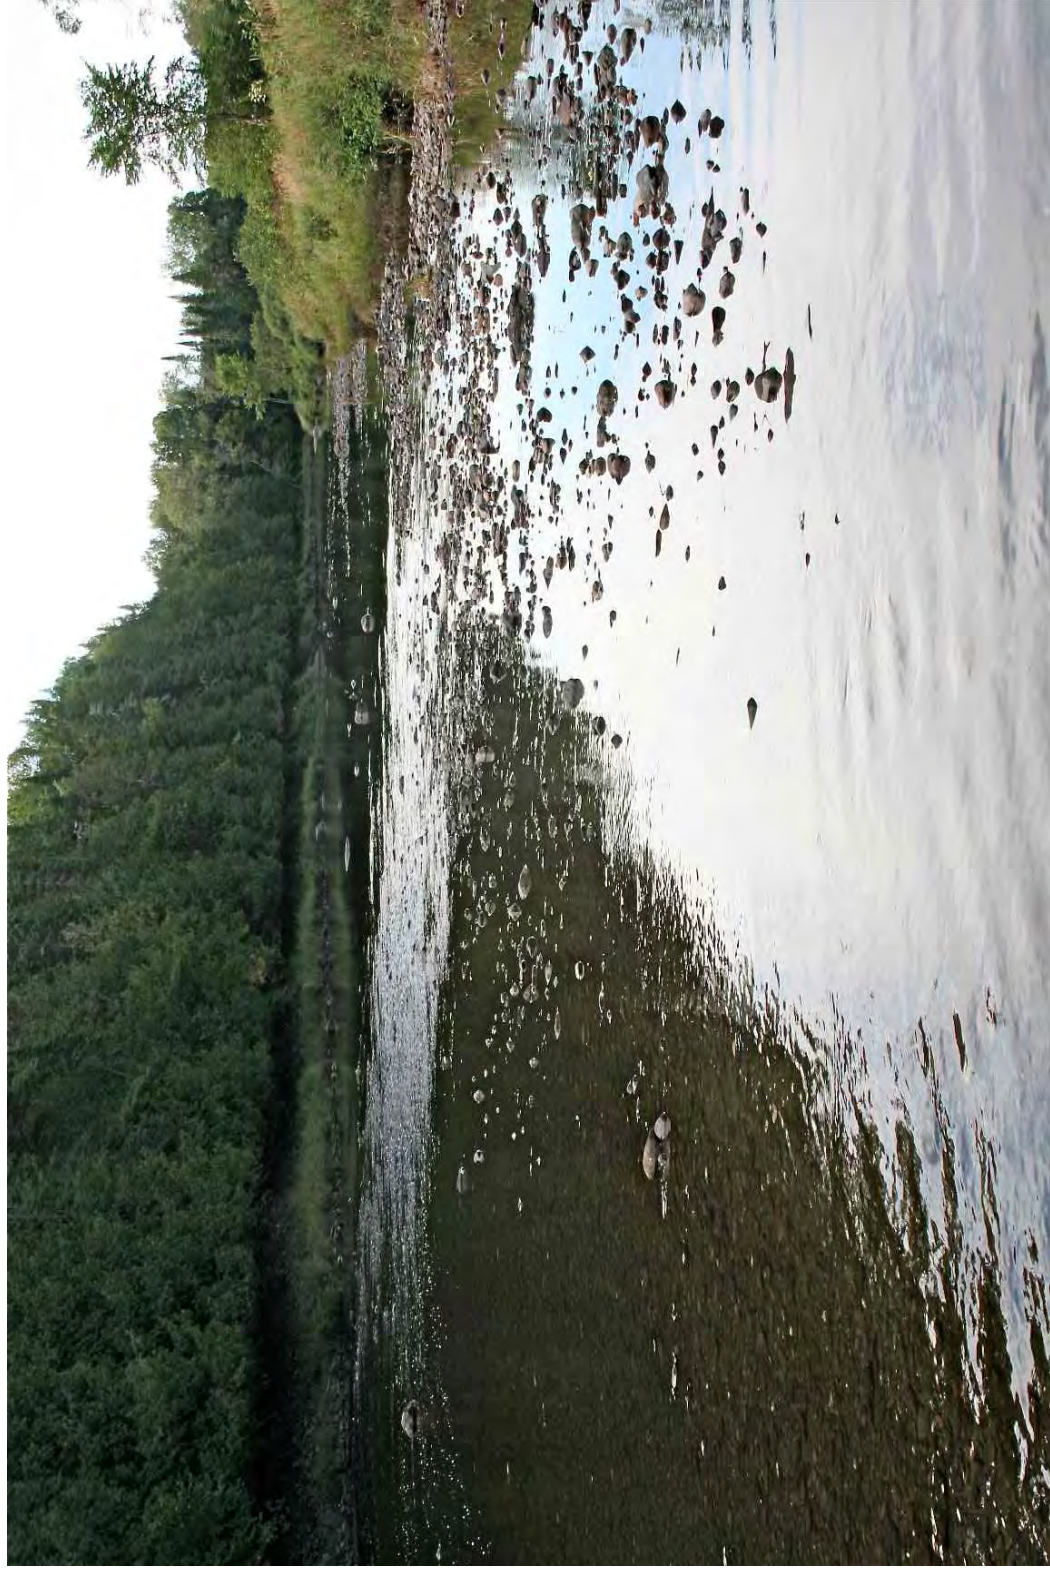
Figure 15. High width:depth ratio channel at the Fish and Game Club site is shallow and slow moving at low flow.

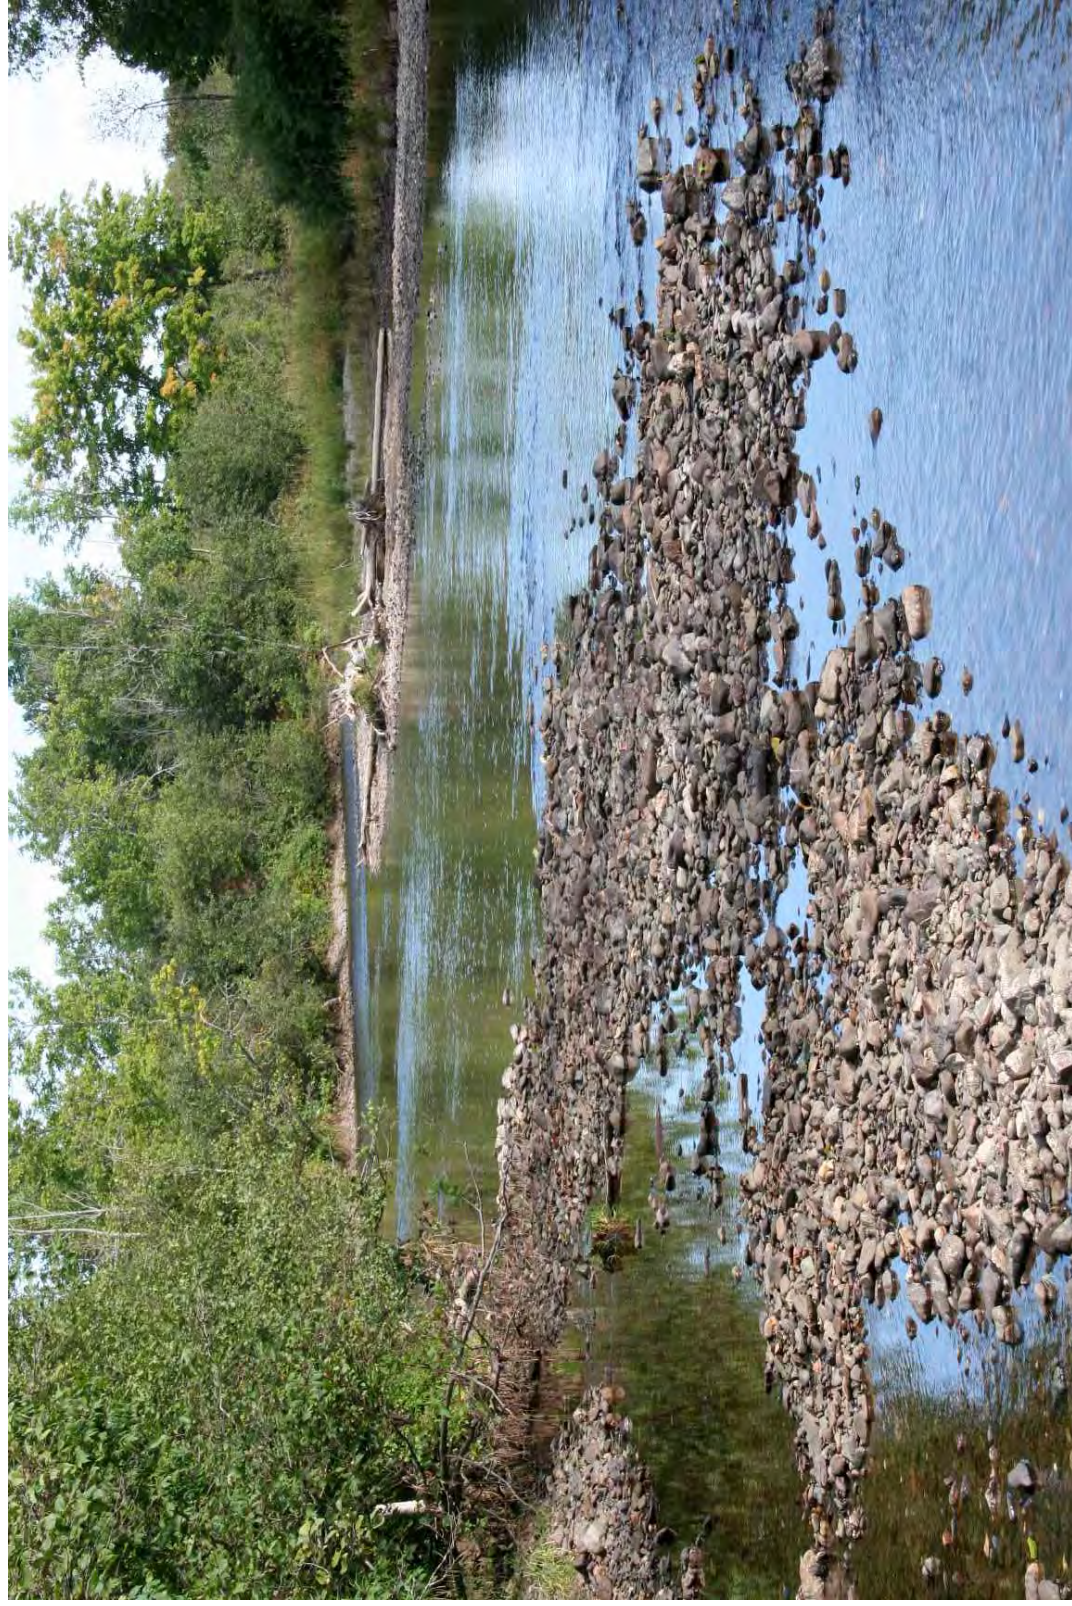
Figure 16. Riparian buffer planting projects will one day provide a supply of trees that will fall into the channel and increase flow complexity and habitat.

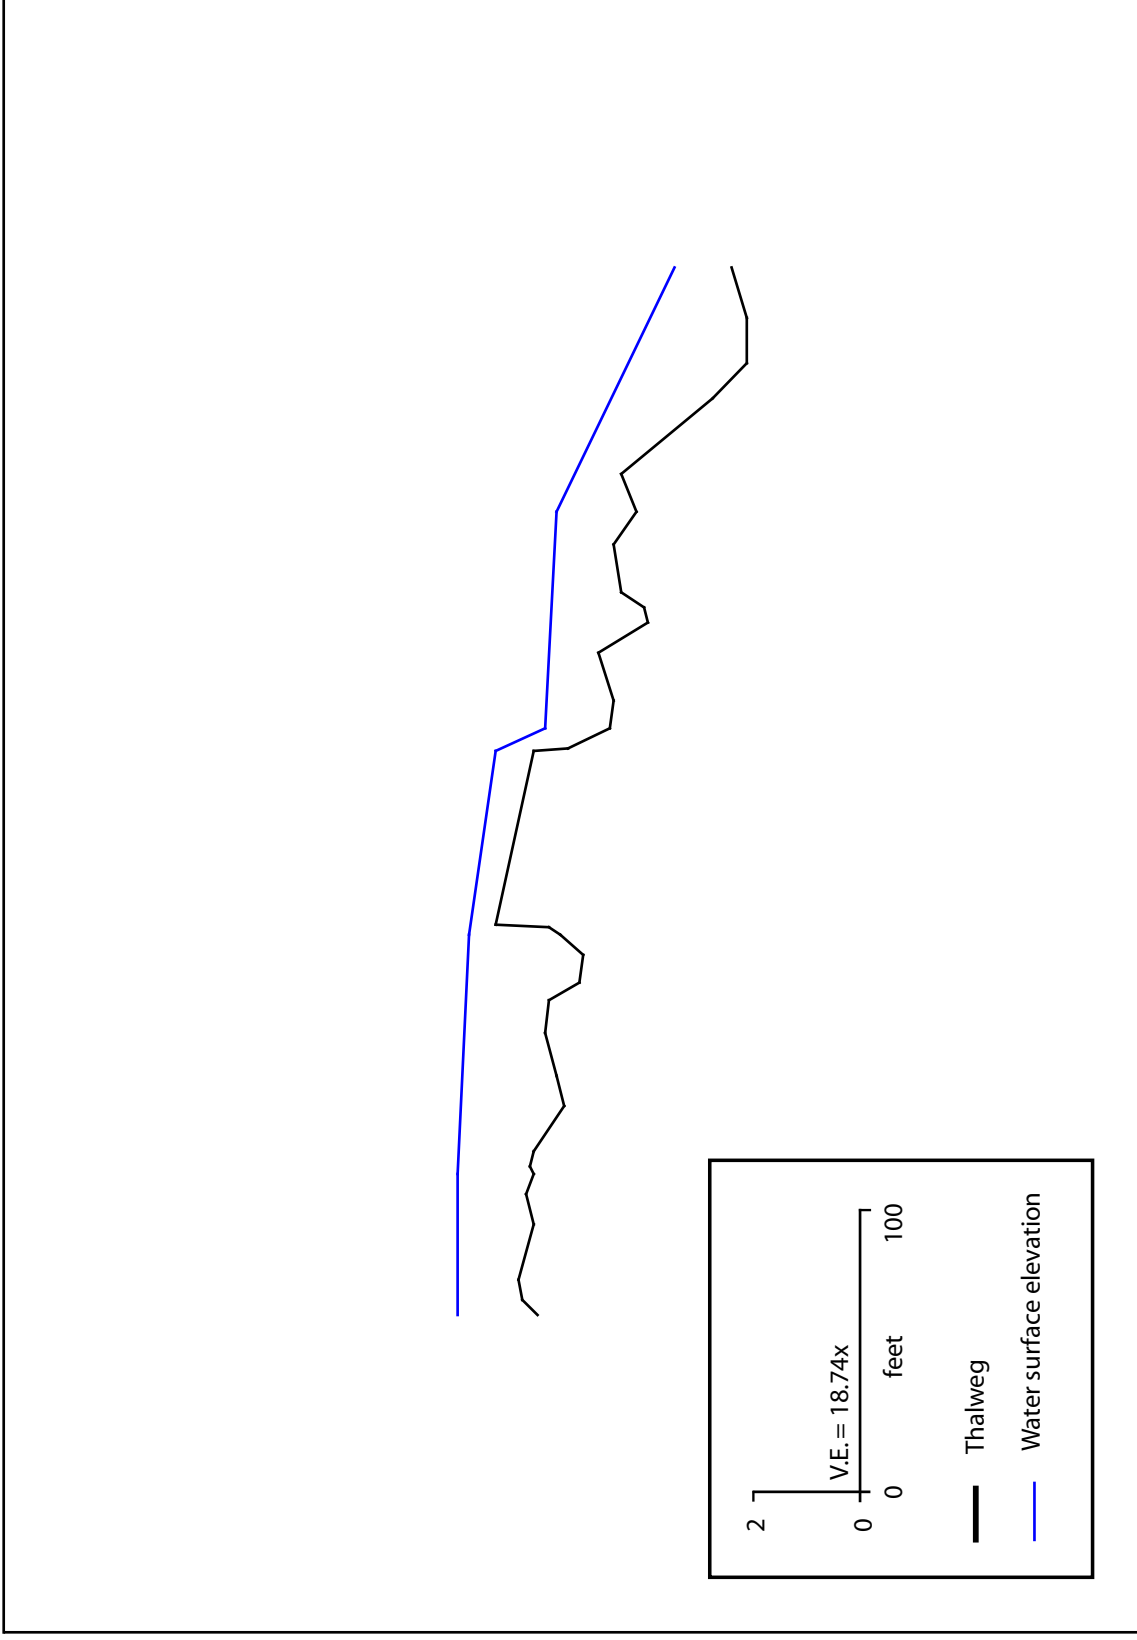
Appendix 6. Topographic survey data planview for Suiter Brook 1 Culvert Assessment Site.

The Suiter Brook 1 culvert significantly constricts the channel. On tribal lands, the culvert might be a good candidate as a demonstration project for culvert replacements with bottomless arch culverts spanning the channel width. However, the culvert was only recently replaced. Suiter Brook has a channel width of less than 20 ft, small enough that shrubby vegetation along the banks provides a canopy over the entire channel (Appendix 9). The dense vegetation and root mass in the bank may inhibit bank erosion and lead to the relatively low width:depth ratio (Table 4). The narrow channel precludes installing significant habitat measures but some small isolated logs placed at the downstream end of the culvert (Appendix 8) will baffle higher velocity flows exiting the highly constricted culvert, providing refuge for fish.

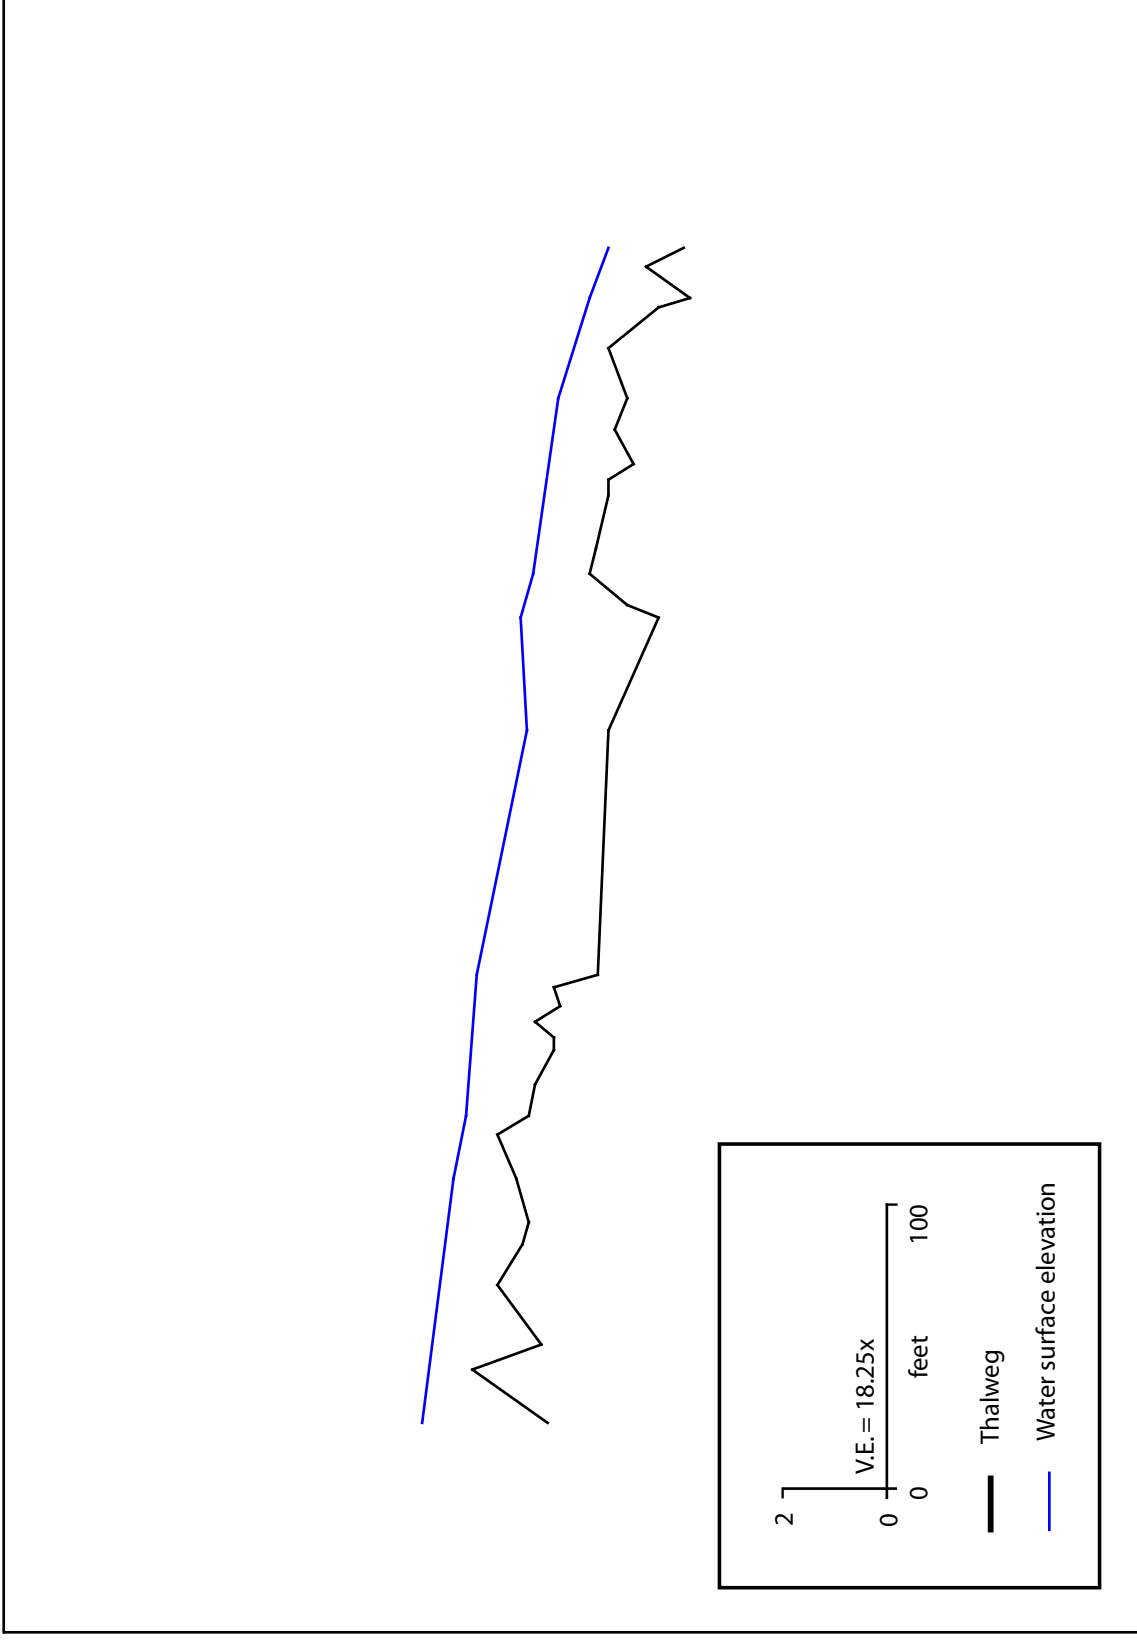
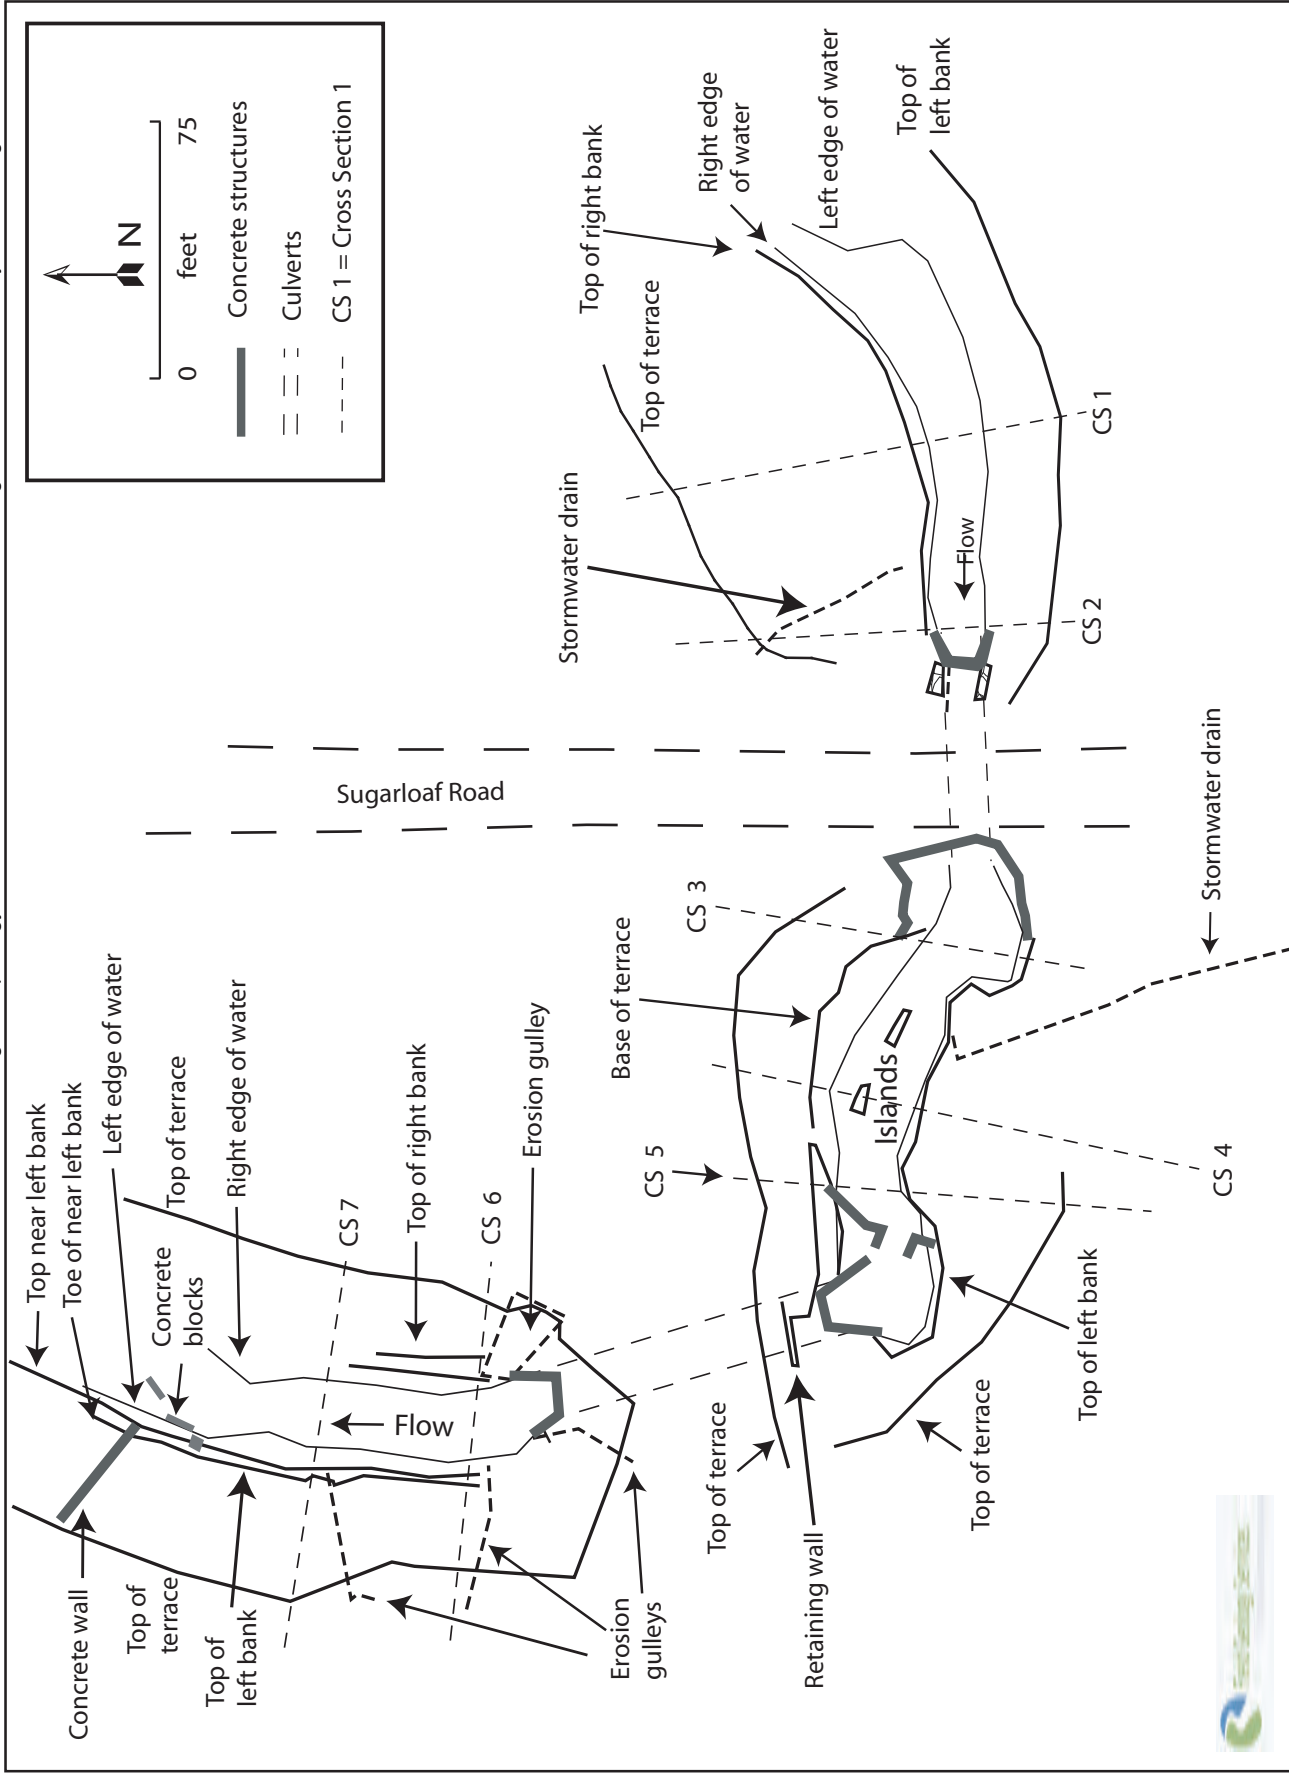
Appendix 6. Topographic survey data cross section for Smith Brook 1 Culvert Assessment Site.

channel morphology (Table 4). The deepest scour pool occurs at Smith Brook 1 where the constriction ratio of 0.39 is high, but not as severe of a constriction as at Moose Brook 1 where the second deepest scour pool is found. In contrast, Brown Brook 2 where the constriction is the least severe has the shallowest scour pool. An equally shallow pool is associated with Suiter Brook 1 with one of the highest constriction ratios, indicating that the severity of the constriction is not the only factor controlling pool depth. Bither Brook 3 was recently replaced by the Maine Department of Transportation using new culvert design guidelines and was chosen as a culvert assessment site to provide a contrast with the older culverts. While Bither Brook 3 does have a lower constriction ratio than most of the other sites, the culvert opening is still only half of the channel width and may explain why a boulder weir built downstream for habitat purposes was outflanked and no longer functions properly (Appendix 6). The culvert is also now slightly perched. Where measured, the culvert slopes are similar to the gradient of the stream channels upstream and downstream, so slope changes are not further compounding channel adjustments occurring in response to the culvert constrictions.

Despite the presence of a double culvert, the constriction at Smith Brook 1 is significant enough to form a deep scour pool downstream and cause erosion of the higher bank flanking the pool (Appendix 9). Upstream of the culvert is a marsh that extends upstream beyond the influence of the culvert, so the culvert is not entirely responsible for the low velocity conditions observed. To protect the bank from further scour, a near vertical log crib wall can be constructed to avoid sloping the bank back and provide rootwads for cover over the pool (Appendix 8). A boulder weir is proposed at the downstream exit of the culvert to prevent perching of the culvert and ease fish passage through the culvert. Partially buried logs, which will also provide cover in the pool, can support the boulders. Additional cover elements can be placed in and around the pool such as isolated boulders and logs.

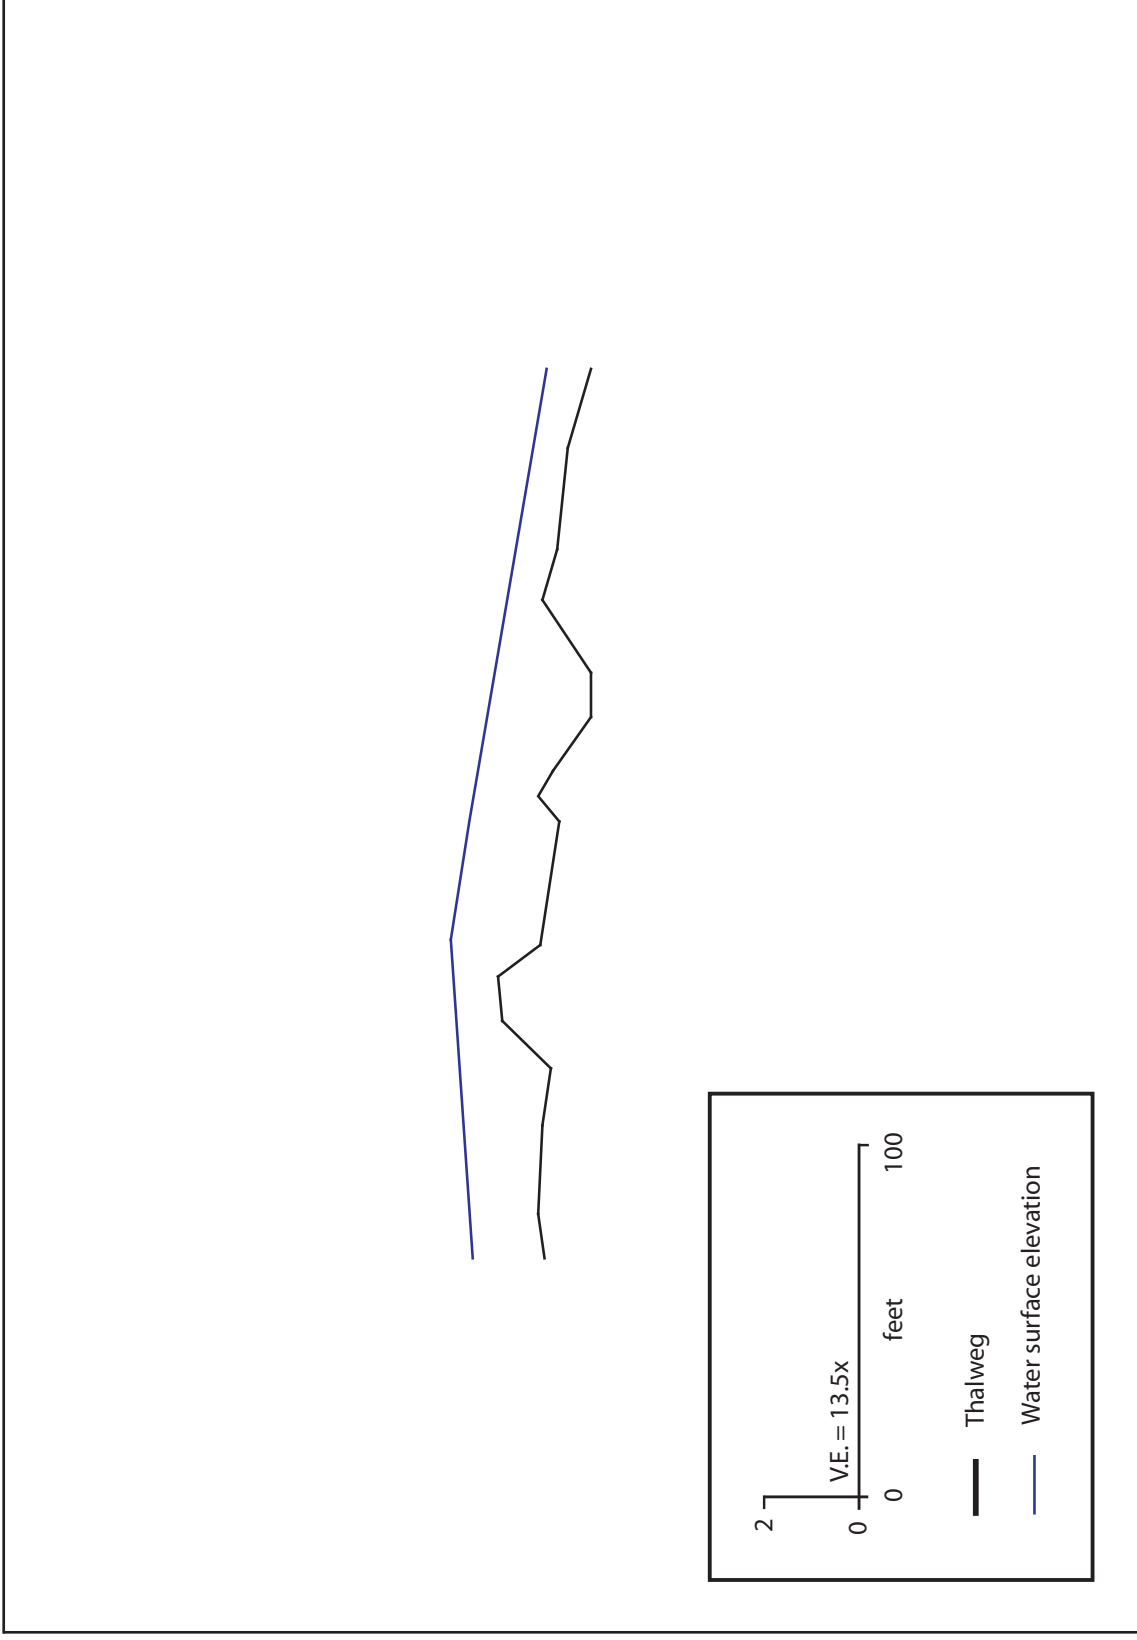
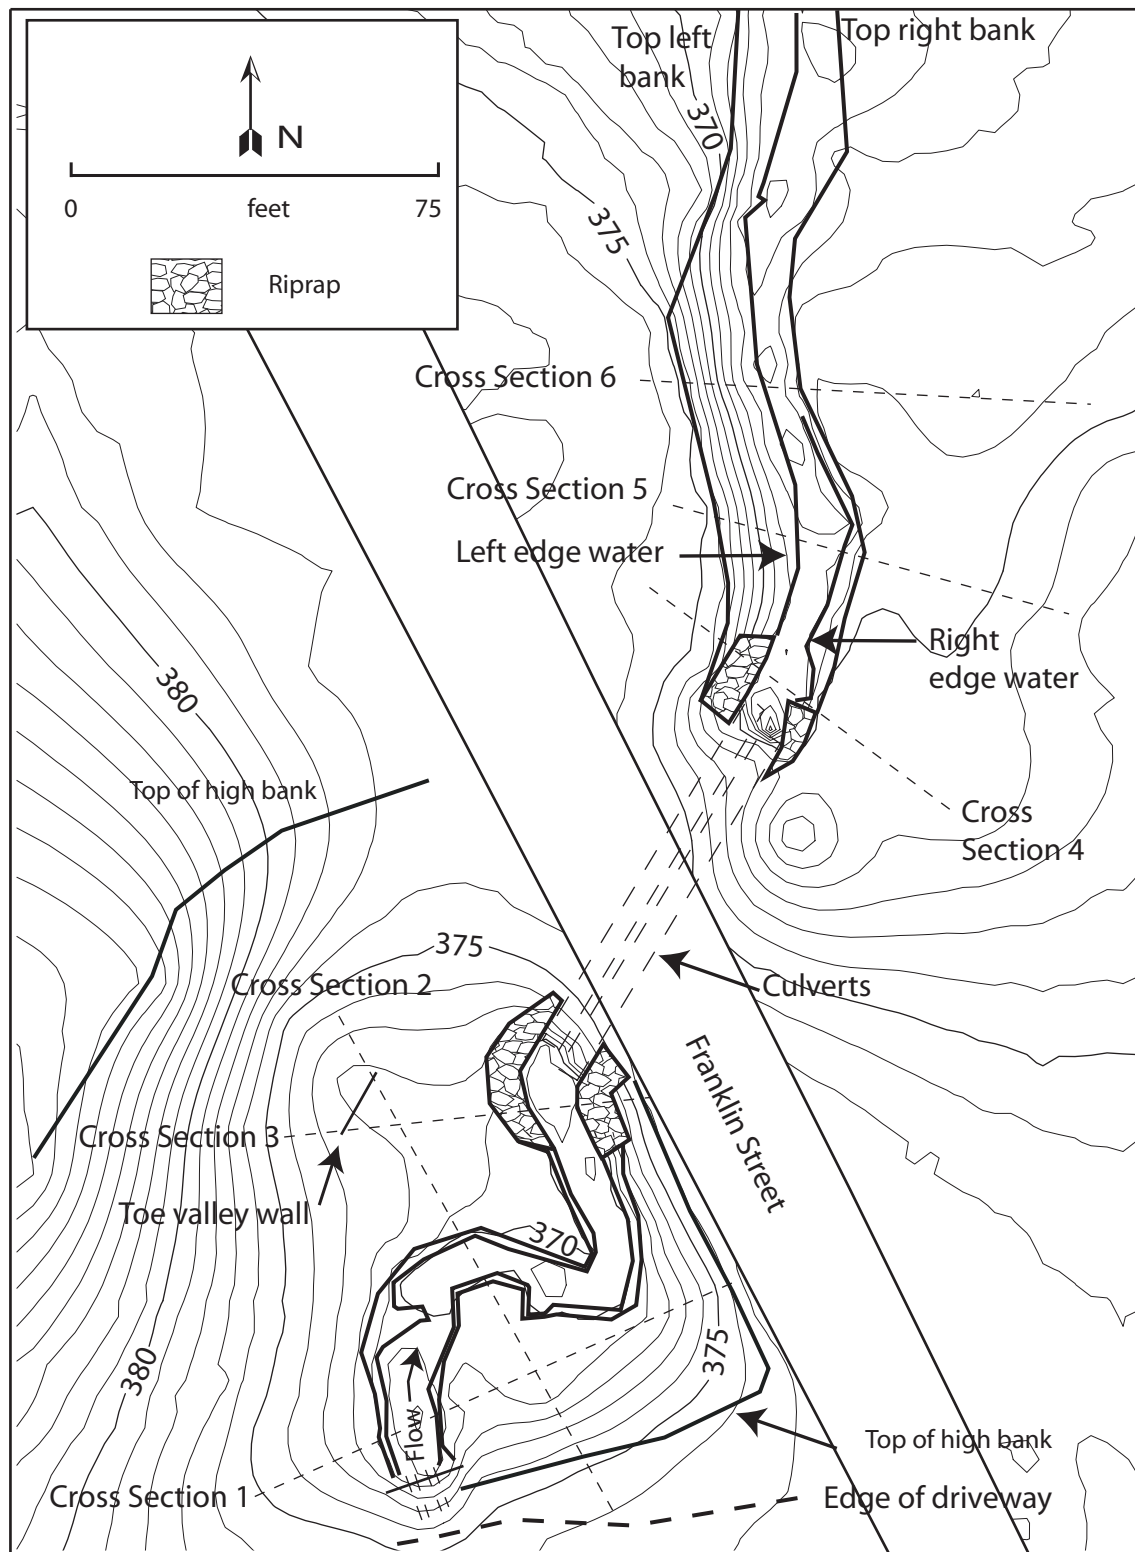
Appendix 6. Topographic survey data cross sections for Pearce Brook 4 Culvert Assessment Site.

The Pearce Brook 4 culvert passes under Green Street in Houlton. The culvert is on the Maine Department of Transportation's priority replacement list, so new culvert designs should plan for a channel spanning bottomless culvert to eliminate the severe constriction. Flood flows can overtop the low bridge and banks, so morphological effects are less severe. Particle size coarsening downstream is significant, but the scour pool depth is less than average for the ten sites (Table 4). Marginal isolated logs are proposed to stabilize an eroding bank upstream of the culvert. The erosion may be unrelated to the culvert, but the logs will provide cover habitat and high velocity refuge near the culvert.
