Fluvial Geomorphology and Culvert Assessment of the Meduxnekeag River Aroostook County, Maine

Houlton Band of Maliseet Indians
Littleton, Maine

Dr. John Field
Field Geology Services
Farmington, ME

July 2010

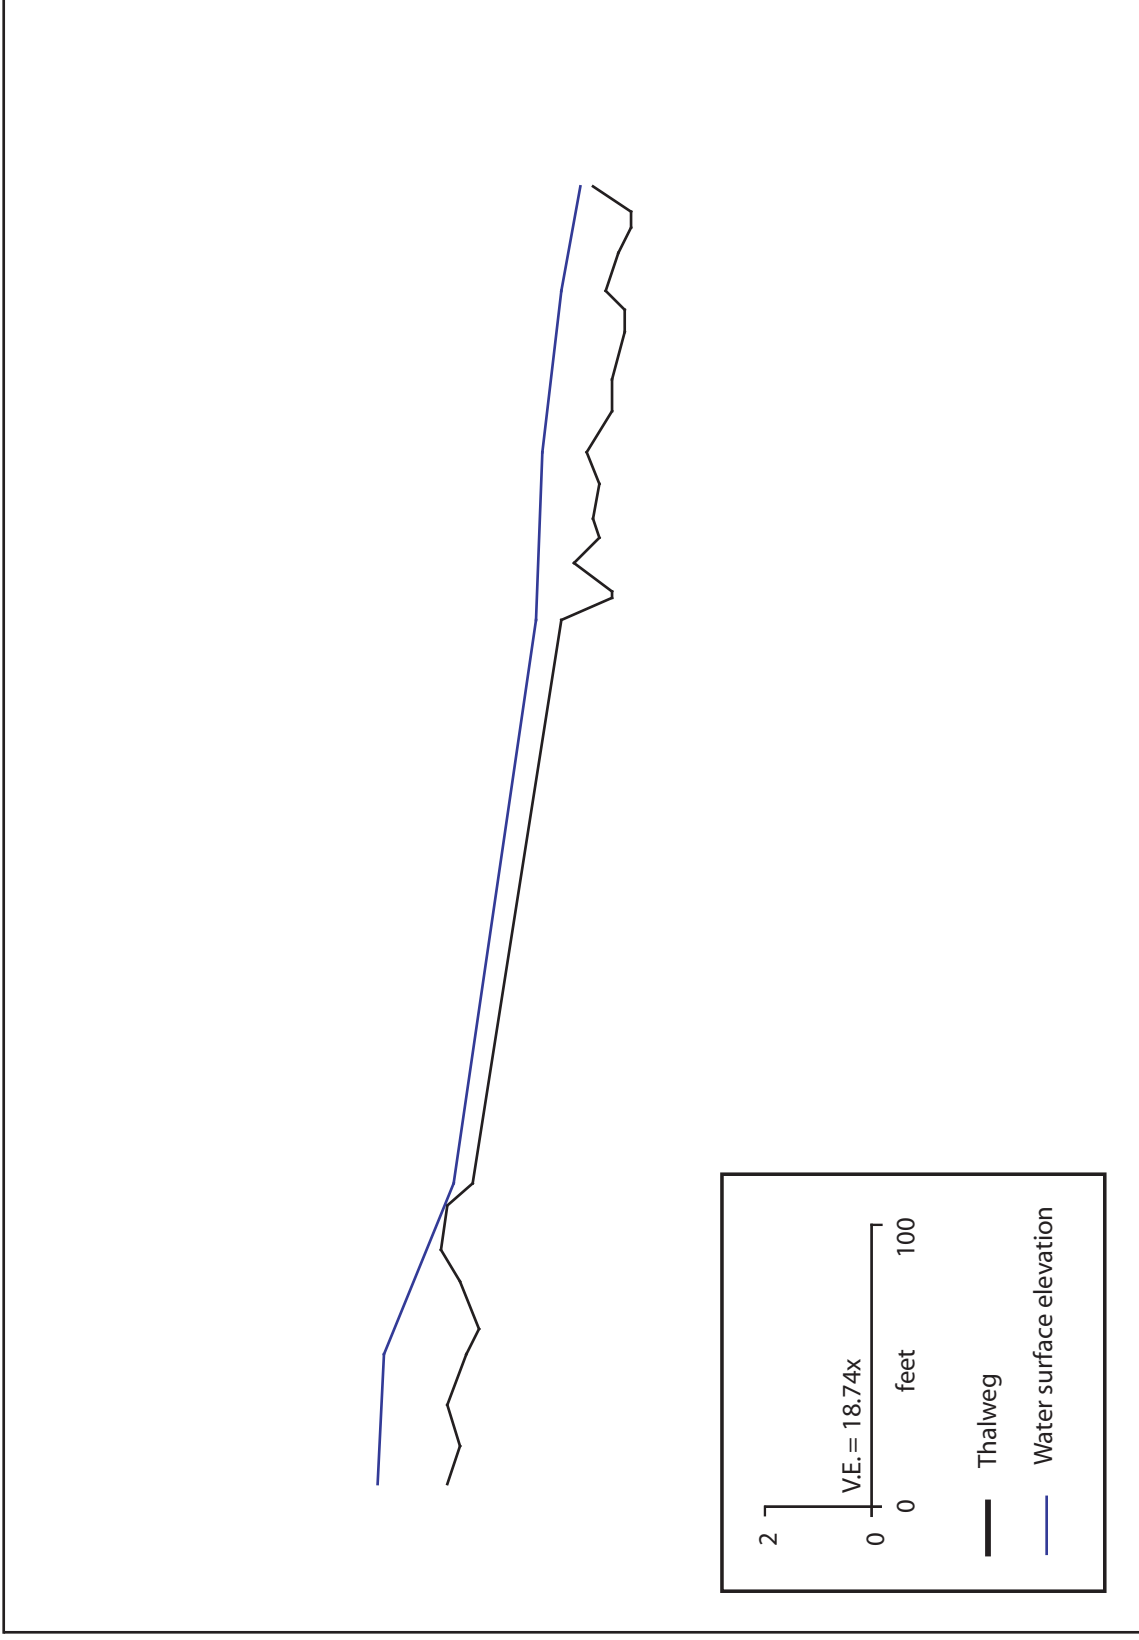
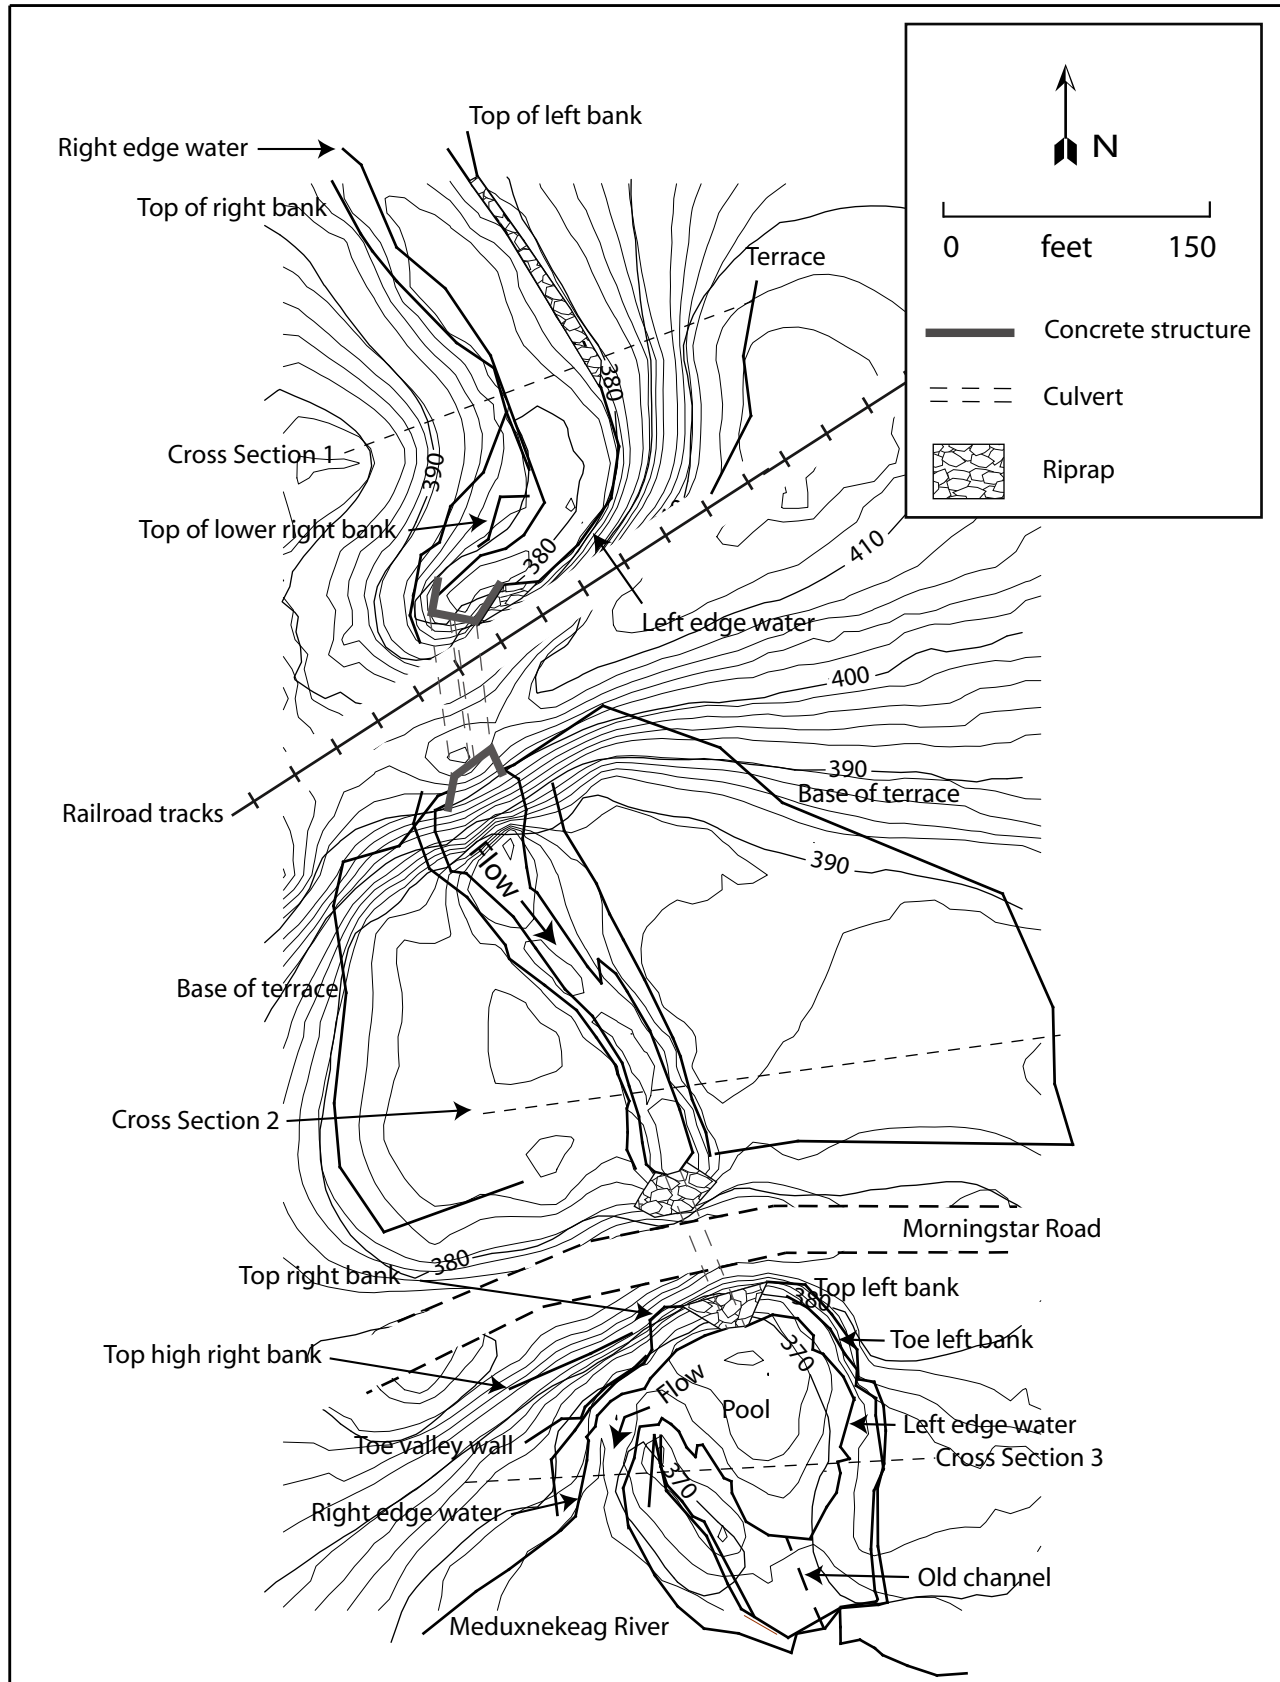
Appendix 6. Topographic survey data cross sections for Brown Brook 3 Culvert Assessment Site.

Brown Brook 3 is a long double pipe culvert running at an angle across Route 1. The fill above the culvert is so thin that frost heaving has caused a portion of the roadway to settle around the pipes, leaving the road undulating over the humps of the culverts. The low road and banks also allow floodwaters to overtop the road with some scour occurring around the culvert at the downstream end as flow returns to the channel (Appendix 9). Mitigation options on this narrow channel are limited but isolated logs are proposed at the downstream end to reduce scour and provide cover habitat.

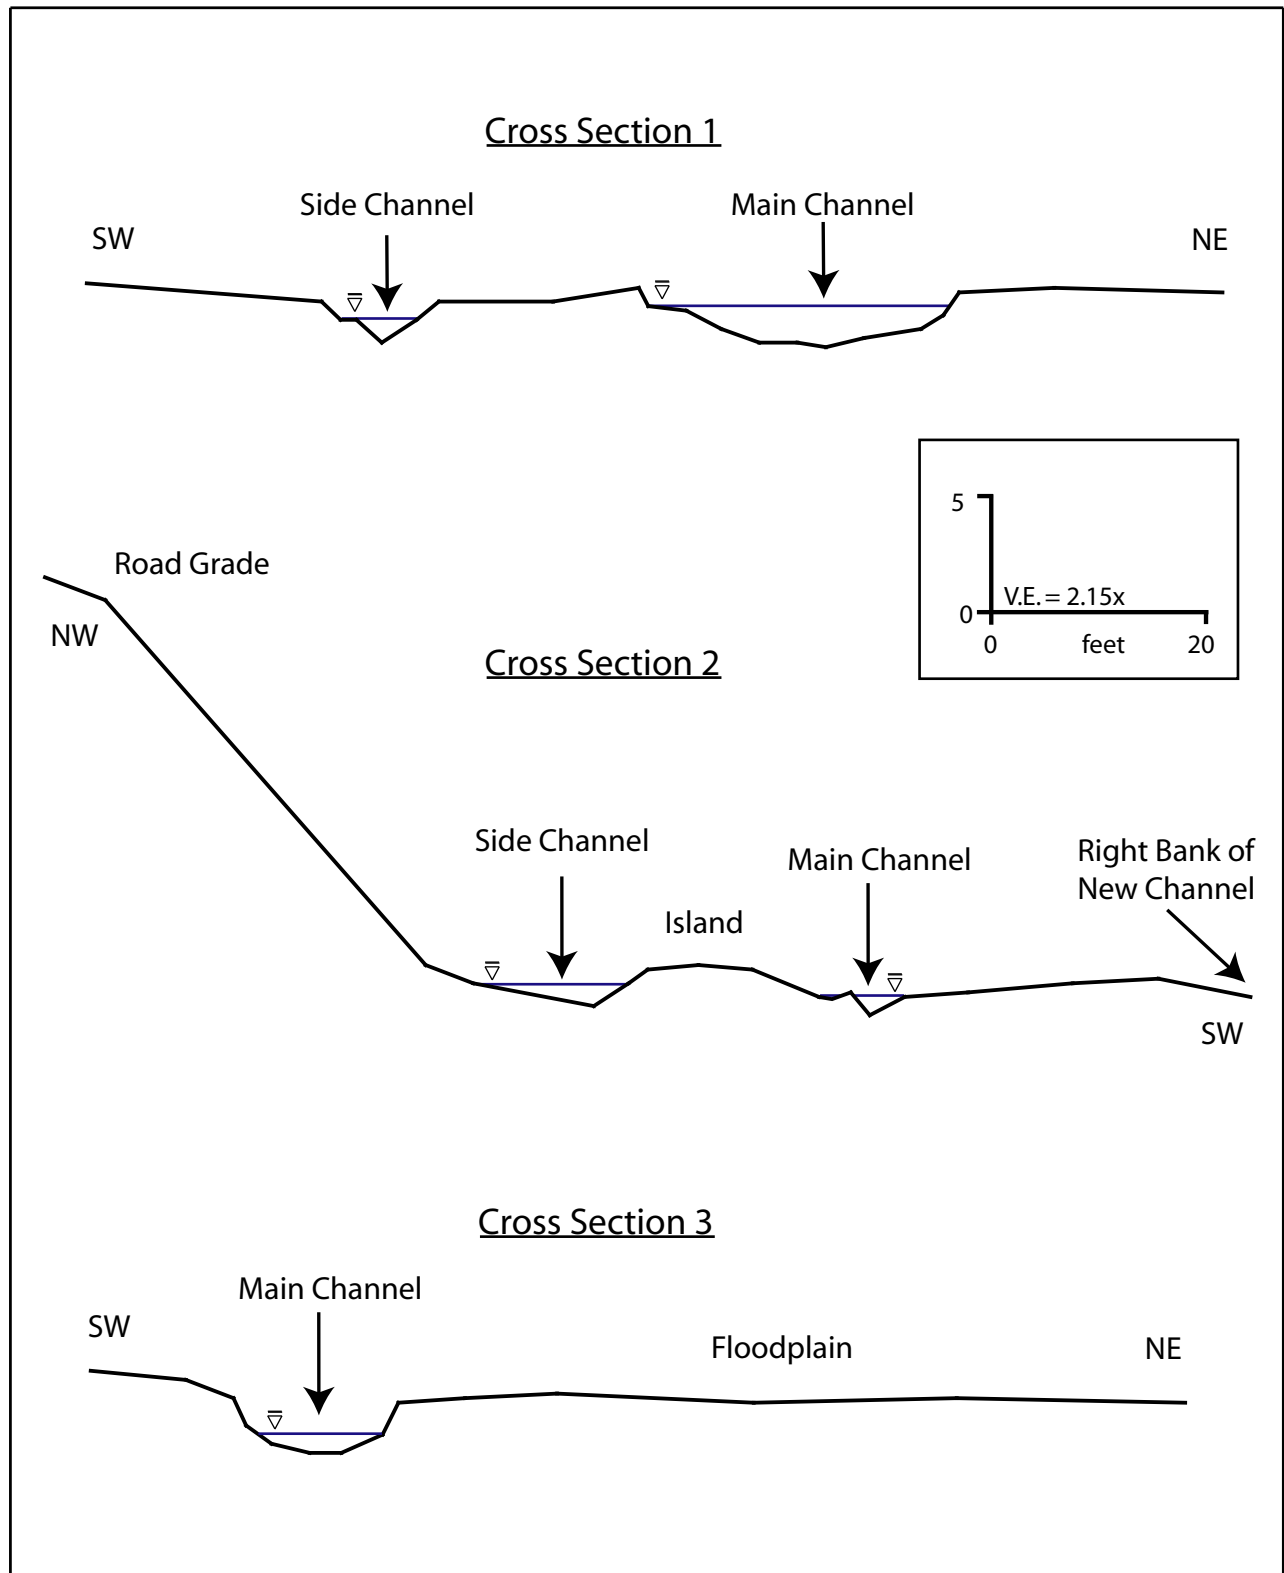
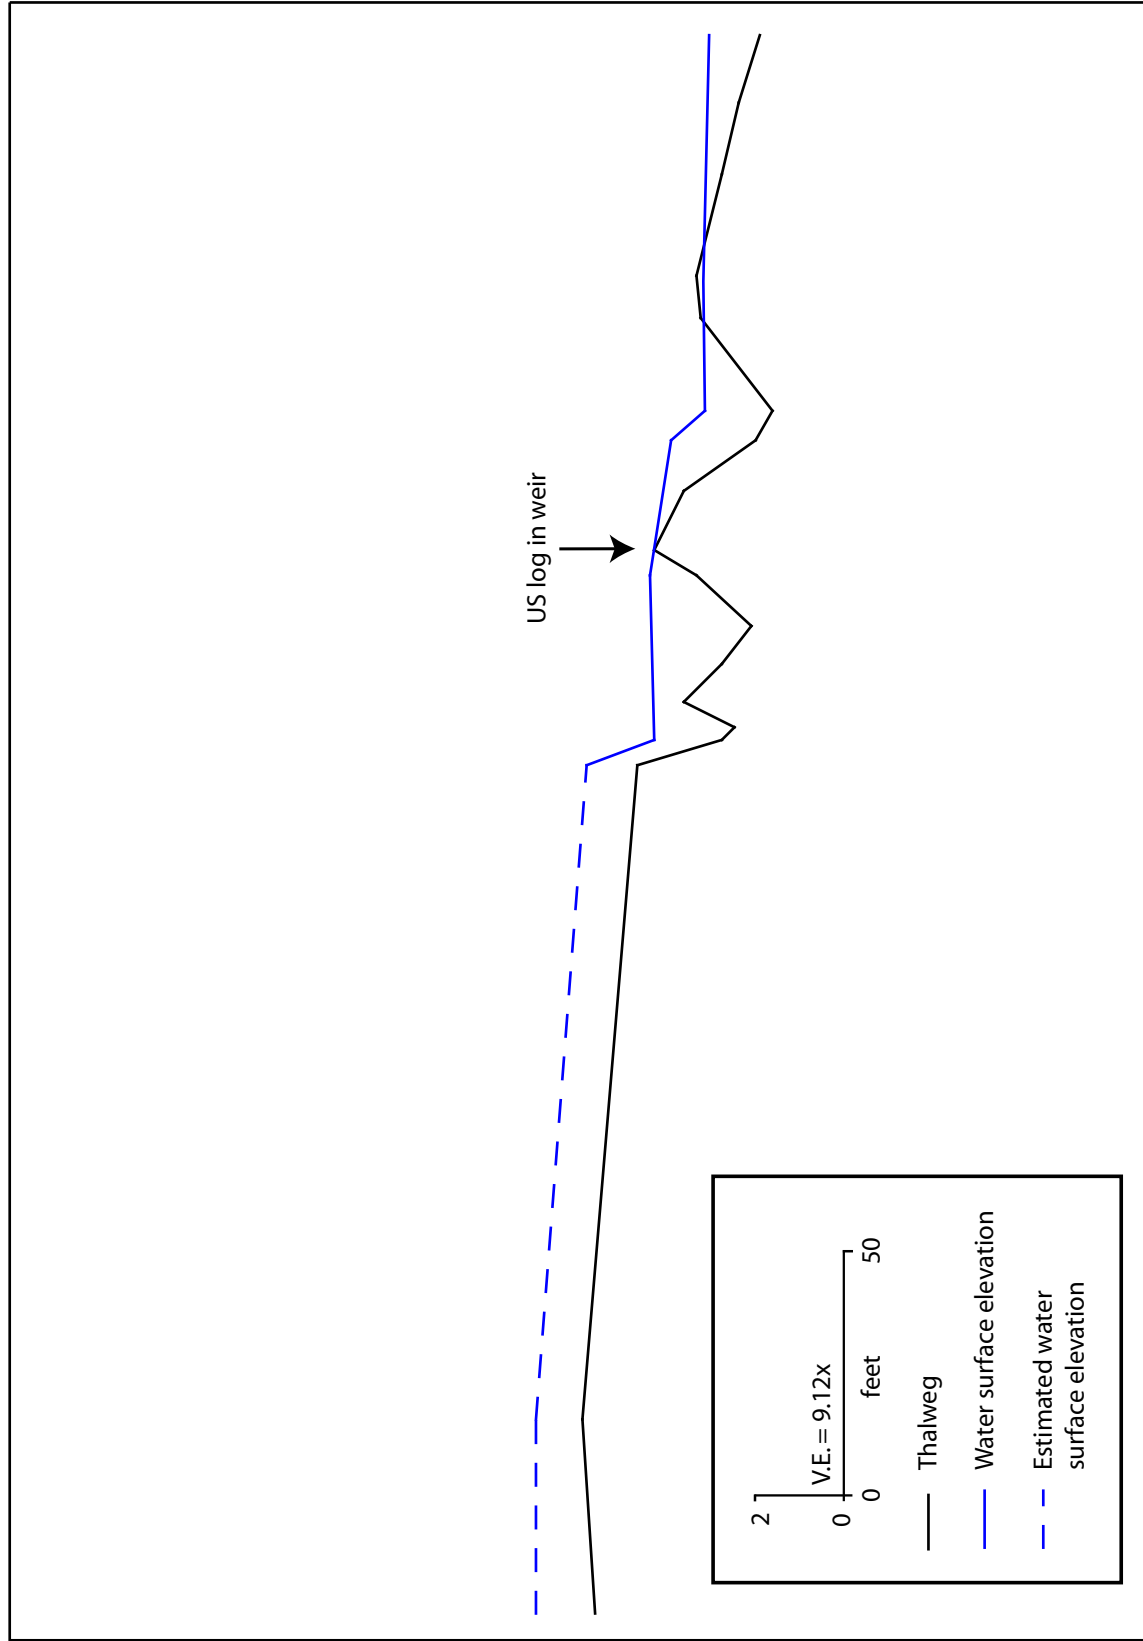
Appendix 6. Topographic survey data cross sections for Bither Brook 3 Culvert Assessment Site.

Bither Brook 3 was recently replaced by the Maine Department of Transportation. Habitat mitigation measures installed with the culvert have been outflanked and are no longer fully functioning. The flow is wide and shallow as it exits the culvert, so boulder clusters and isolated logs are proposed at the outlet to increase pool depth and cover habitat (Appendix 8). A weir is also proposed to help concentrate flow into a single area. The culvert is slightly perched (Appendix 9), so a second boulder weir could be constructed at the outlet to improve fish passage, but is not shown on the conceptual habitat mitigation design (Appendix 8).

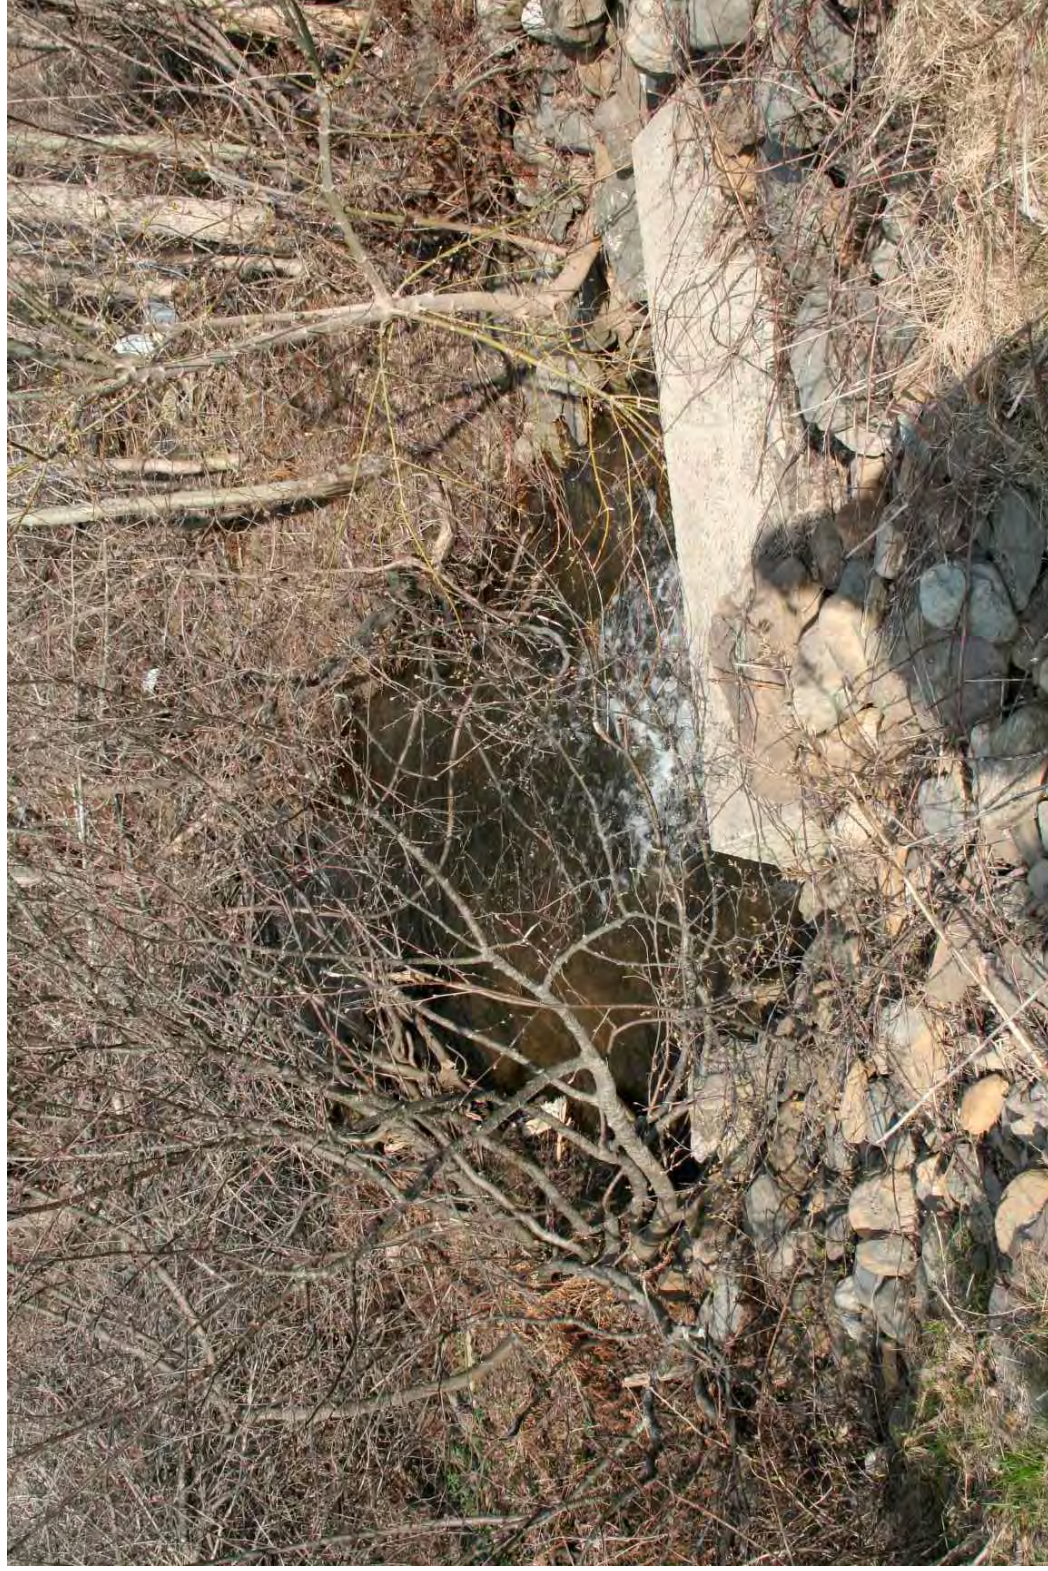
Appendix 9. Ground photograph of Suiter Brook 1.

The Suiter Brook 1 culvert significantly constricts the channel. On tribal lands, the culvert might be a good candidate as a demonstration project for culvert replacements with bottomless arch culverts spanning the channel width. However, the culvert was only recently replaced. Suiter Brook has a channel width of less than 20 ft, small enough that shrubby vegetation along the banks provides a canopy over the entire channel (Appendix 9). The dense vegetation and root mass in the bank may inhibit bank erosion and lead to the relatively low width:depth ratio (Table 4). The narrow channel precludes installing significant habitat measures but some small isolated logs placed at the downstream end of the culvert (Appendix 8) will baffle higher velocity flows exiting the highly constricted culvert, providing refuge for fish.

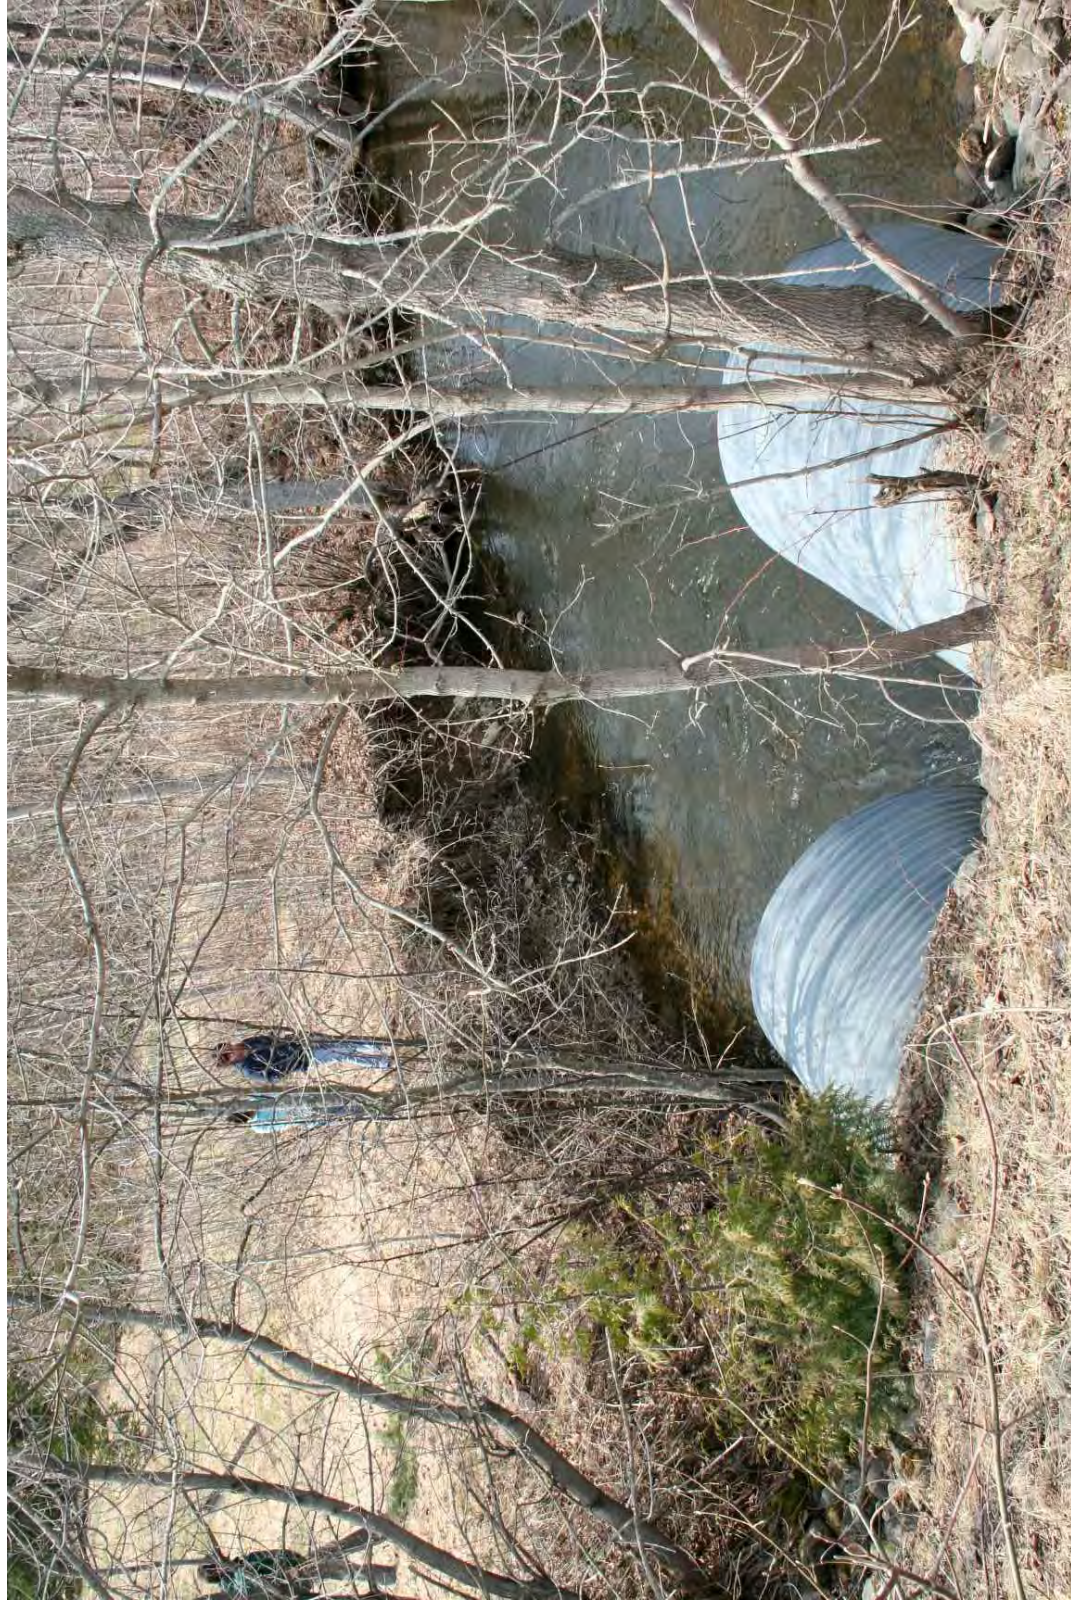
Appendix 9. Ground photograph of Smith Brook.

Despite the presence of a double culvert, the constriction at Smith Brook 1 is significant enough to form a deep scour pool downstream and cause erosion of the higher bank flanking the pool (Appendix 9). Upstream of the culvert is a marsh that extends upstream beyond the influence of the culvert, so the culvert is not entirely responsible for the low velocity conditions observed. To protect the bank from further scour, a near vertical log crib wall can be constructed to avoid sloping the bank back and provide rootwads for cover over the pool (Appendix 8). A boulder weir is proposed at the downstream exit of the culvert to prevent perching of the culvert and ease fish passage through the culvert. Partially buried logs, which will also provide cover in the pool, can support the boulders. Additional cover elements can be placed in and around the pool such as isolated boulders and logs.

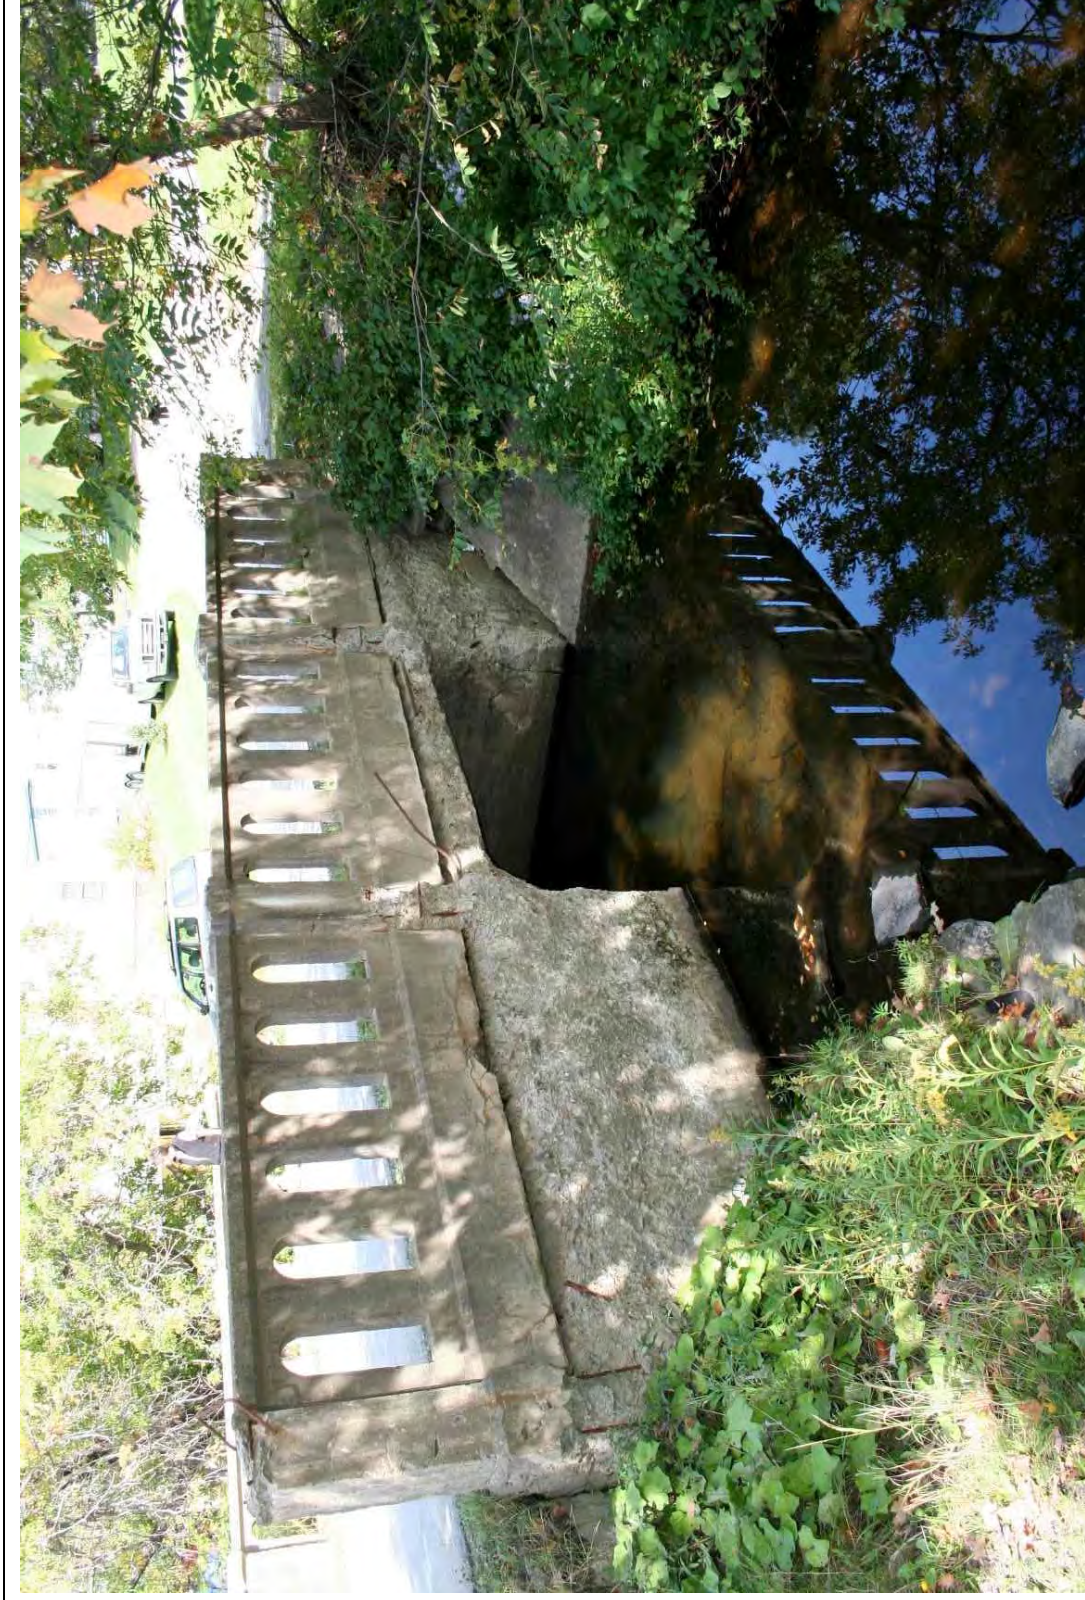
Appendix 9. Ground photograph of Pearce Brook 4.

The Pearce Brook 4 culvert passes under Green Street in Houlton. The culvert is on the Maine Department of Transportation's priority replacement list, so new culvert designs should plan for a channel spanning bottomless culvert to eliminate the severe constriction. Flood flows can overtop the low bridge and banks, so morphological effects are less severe. Particle size coarsening downstream is significant, but the scour pool depth is less than average for the ten sites (Table 4). Marginal isolated logs are proposed to stabilize an eroding bank upstream of the culvert. The erosion may be unrelated to the culvert, but the logs will provide cover habitat and high velocity refuge near the culvert.
